Service Bulletin

Bulletin No.: PIT5072C

Subject: Power Liftgate Does Not Stay Fully Open Or Drifts Down A Few Inches

Models: 2010 - 2012 Chevrolet Equinox
2010 - 2012 GMC Terrain

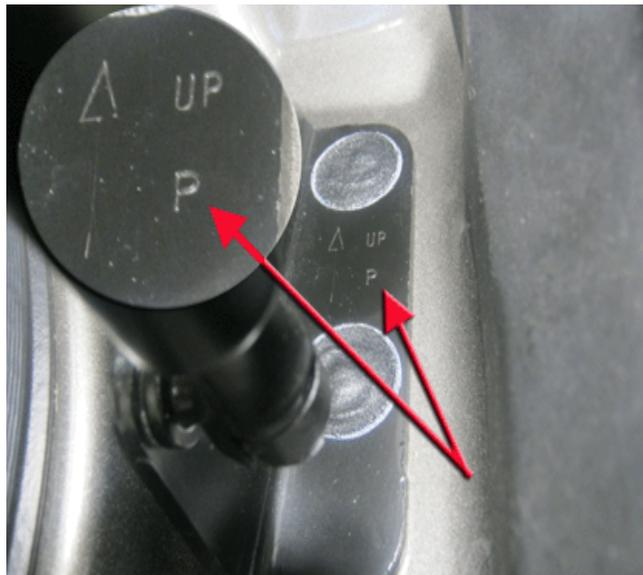
2598278

The picture above is an example of the correct brackets for a power liftgate

This may be caused by the incorrect strut mounting brackets installed on the vehicle. Check on the liftgate mounting brackets for a letter P or M stamped on the bracket. P is for power liftgate and M is for Manual liftgate. If Manual strut mount brackets are found on the vehicle replace with the correct bracket(s) for power liftgate.
