Service Bulletin

Bulletin No.: PIT5184

Subject: Various Concerns Related To The IP Backlighting Cruise Control Steering Wheel Controls Horn

Models: 2007-2013 Cadillac Escalade Models
2007-2013 Chevrolet Avalanche, Silverado, Suburban, Tahoe
2007-2013 GMC Sierra, Yukon Models

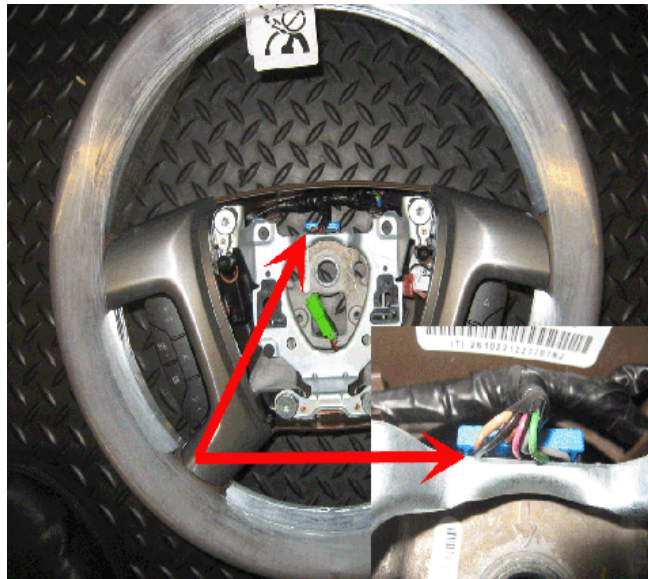
2917745

Inspect for a short to ground on the steering wheel near the SIR coil connector X2, see picture below. Depending on which circuit is shorted, this will cause any of the various symptoms mentioned above.

Make necessary repairs to any shorted circuits and then position the wiring so it will no longer make contact with the steering wheel.
