Service Bulletin

Bulletin No.: PIP5009F

Subject: Replace the Internal Transmission Wiring Harness and TCC Enable Solenoid Anytime the Transmission is in for Service - Malfunction Indicator Lamp (MIL) With DTC P0741 Set and Harsh 1-2 shift Vehicles manufactured after 10/01/11

Models: 2012 Chevrolet Colorado, Express, Silverado
2012 GMC Canyon, Savana, Sierra
All Equipped with Automatic Transmission 4L60E (RPO M30). Built after 10/01/11

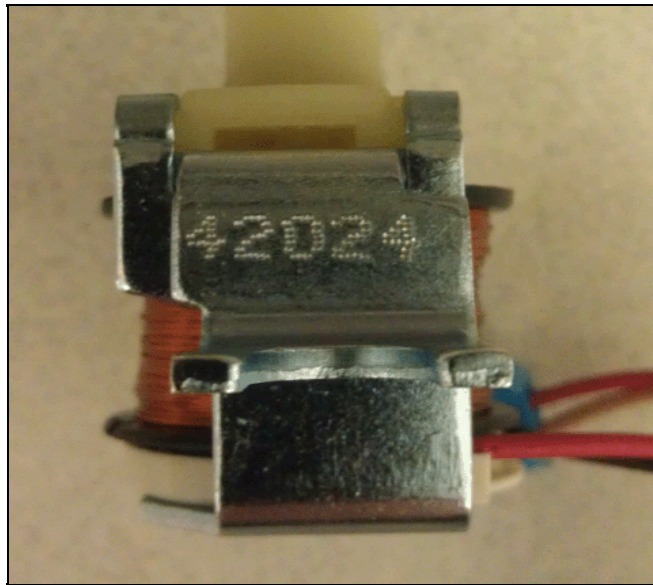
2854421

Note: To prevent multiple TCC Enable Solenoid and Wire Harness replacements check the five digit date code on the TCC Enable Solenoid body to see if it has been replaced.

The first digit (month of build) should be a 4 or higher or an alpha character. The second and third digits are the day of the month. The fourth digit should be a 2 or 3 (calendar year 2012, 2013).

The fifth digit (line of build) should be a numeric character typically a 3 or 4 Example: 42024 shown in the picture below was produced April 20, 2012 on line 4.

Any solenoid produced on or after April 4, 2012 date code of 4042# or greater does not need to be replaced.

Important: Replace the TCC Enable Solenoid and Wire Harness part number 24237980 anytime repairs are being performed on the transmission on vehicles manufactured after 10/01/11.
