# Service Bulletin

Bulletin No.: PIP5052A

**Subject:** Flutter Noise At High RPM Driving And On Deceleration At Highway Speed - Inspect Transmission Tag

**Models:** 2012 - 2013 Chevrolet Camaro ZL1  
With 6.2L Supercharged Engine (RPO LSA)

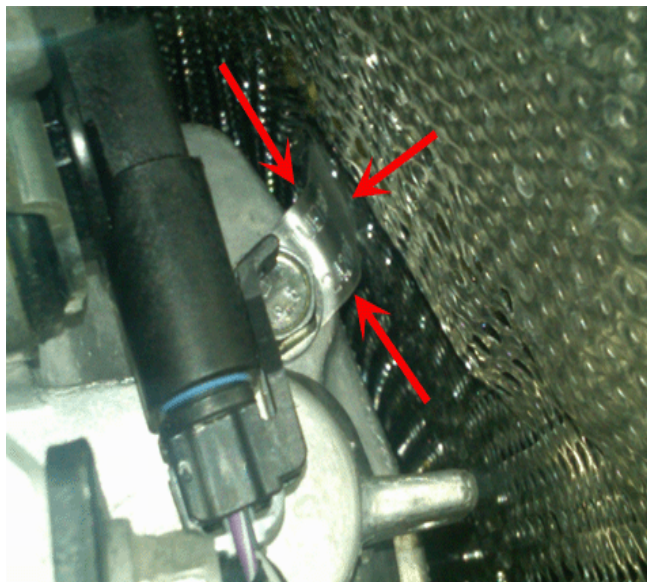
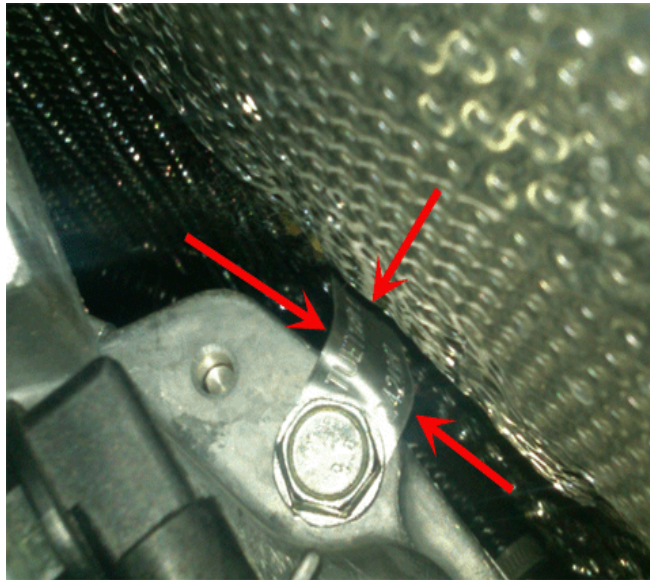
2895162

Some customers may complain of an engine or supercharger noise during a high RPM deceleration from highway speed.

Inspect the transmission ID tag to determine if it is making contact with the transmission tunnel as shown below and reposition the tag as necessary.

Labor Operation	Description	Labor Time
K9713	Inspect/Reposition Transmission ID Tag to Correct Noise Concern	.3 hr
