# Service Bulletin

Bulletin No.: PIP5063

**Subject:** Squeak Noise While Driving From Propeller Shaft

**Models:** 2013 Cadillac ATS  
Built Prior to VIN: 1G6AB5RA5D0114835 (9/14/2012)

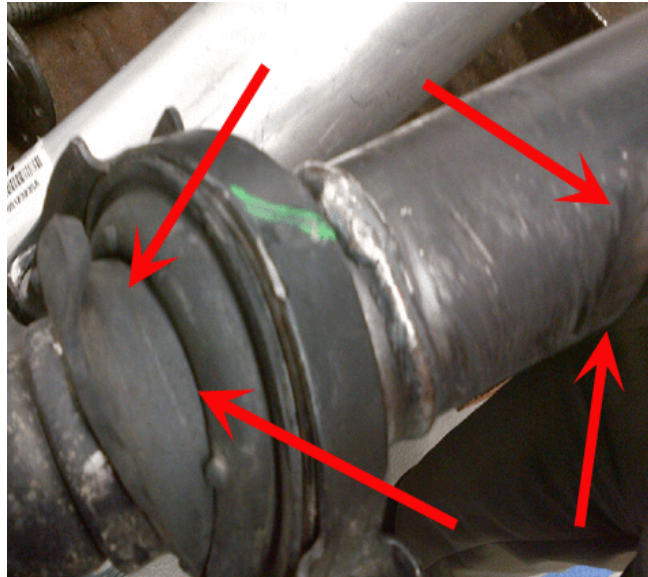
2889056

In rare instances, a squeak noise may be heard while driving on vehicles built before the breakpoint shown above. This information applies to 2wd and AWD vehicles. This noise may be caused by contact between a water deflector and center support bearing of the rear propeller shaft. To aid in diagnostics while allowing the propeller shaft to spin with the vehicle on a hoist, spray lubricant on the bearing where the water deflector contacts the bearing (See arrows below). This should eliminate or change the noise.

If the noise is eliminated or changed as described above replace the rear propeller shaft.
