Service Bulletin

Bulletin No.: PIP5065A

Subject: Ticking Noise In 3rd And 4th Gear Above 30 MPH

Models: 2012 Chevrolet Colorado
2012-2013 Chevrolet Express, Silverado
2012 GMC Canyon
2012-2013 GMC Savana, Sierra
Equipped with 4L60E (M30) Automatic Transmission

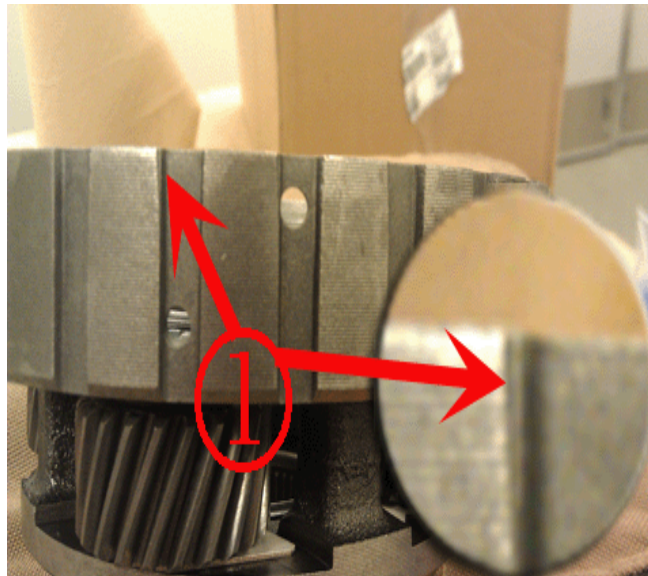
2914493

This concern may be caused by a mis-machined reaction carrier which may cause the low reverse clutch plates to stick and release creating the ticking noise.

Call out 1

Shows a taper in the machined surface of the reaction carrier lug.

This mis-machined hub is causing the low reverse clutch plates to stick and release creating the ticking noise

Replace the Reaction Carrier and low reverse clutch plates.
