# UPDATE Technical Bulletin

October 09, 2012 2011165

## UPDATE – 64C7 Window Motors - (US ONLY)

This update has been proactively released to prevent window(s) entering pinch protection with no obstructions present.

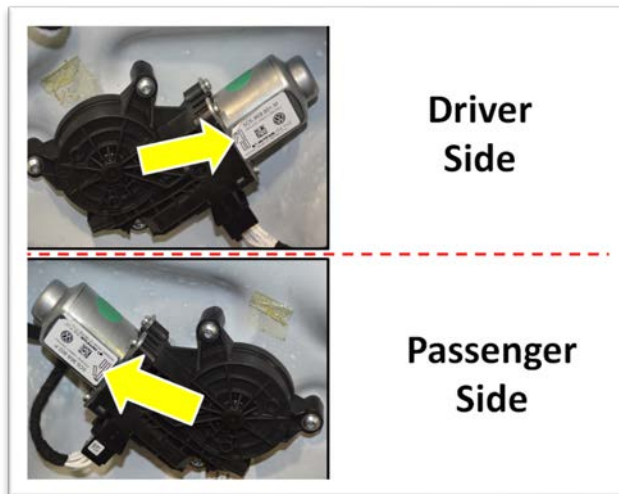
- ⇐ Check the part numbers <arrows> on the Driver Side and Passenger Side Window Regulator Motors:
  - If part numbers on motors are as listed in table below, go to Section C to reinstall door trim.
  - If either one or both part numbers are not as listed below, CONTINUE as necessary to replace one or both motors.

Motor Position	Motor Part #
Driver Side	5C5.959.801.M
Passenger Side	5C5.959.802.P
