Model(s)	Year(s)	Eng. Code(s)	Trans. Code(s)	VIN Range From	VIN Range To
(A5) Rabbit, GTI	2006-2007	All	All	All	All
(A5) Jetta	2005-2007	All	All	All	All

**01 12 30** October 3, 2012 **2012705** Supersedes T. B. V010615 dated September 19, 2006 to update warranty information.

#### Engine, Cranks Intermittently or No Crank

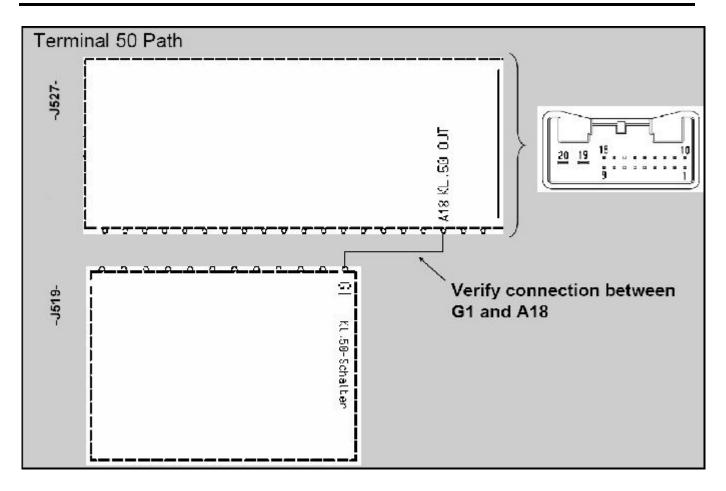
Circuit path: Pin 1 on the 12 pin G connector of Vehicle Electrical System Control Module -J519- to pin 18 on the 20 pin connector of the Steering Column Electronic Systems Control Module -J527-.

Steering Column Electronic Systems Control Module -J527- located under steering column, -arrow-.

Connector G located on top of Vehicle Electrical System Control Module -J519-, -arrow-.

• Replace Steering Column Electronic Systems Control Module -J527-. See Repair Manual Group 94 - Lights, Switches - exterior, Steering Column Switches.
