SUBJECT: Pump Shift Air Tank Plumbing

Customer Service Bulletin 2012-0653

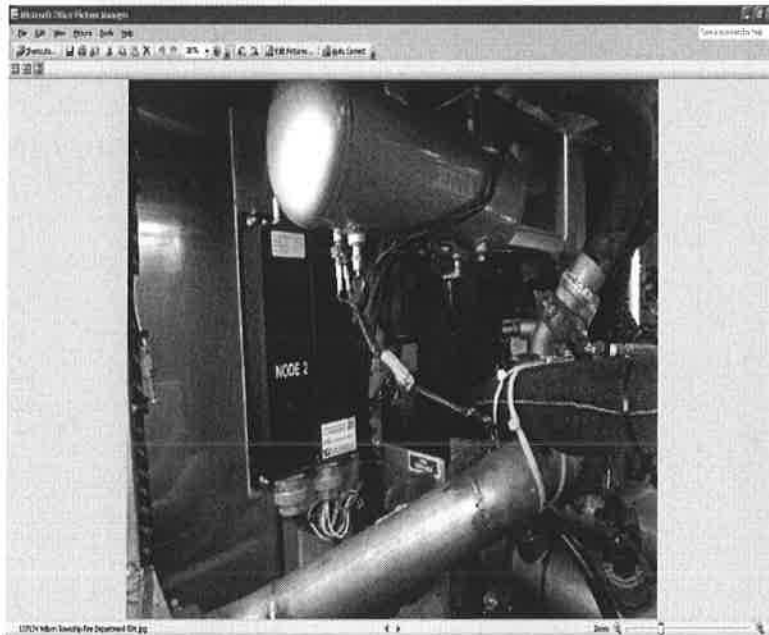
It has recently been discovered that some units equipped with a Viair air delivery system were plumbed incorrectly at the air tank. This will cause excessive moisture which could lead to the pump shift line freezing up in extreme cold. The recommendation to resolve this issue is to remove all of the components from the bottom of the tank except the tank drain valve. Plug the remaining 3 ports at the bottom of the tank with brass plugs. Use brass adapters and tees in the single port at the top of the tank to accommodate the 3 components removed from the bottom of the tank. Below is a photo of the incorrect installation.
