Service Bulletin

**SUBJECT: Service Update for Inventory Vehicles Only
Steering Wheel Doesn't Heat, Horn Continuous, Battery Drain
Expires December 31, 2013**

MODELS: 2013 Cadillac XTS

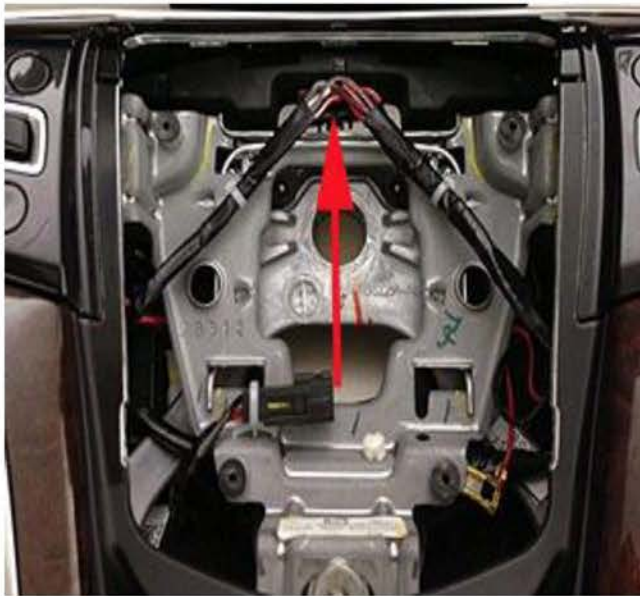
2966068

2. Inspect the steering wheel metal base plate.
 - If you see a RED or BLACK line under the airbag retention spring between the left and right branches of the main wire harness, the steering wheel has already been reworked. No further rework is required. Inspect the wiring and ensure there is no damage to wires and reposition the heated steering wheel wire harness as shown in UVD step #5. Reinstall the airbag module into the steering wheel.
 - If no black or red indicator is found, proceed to step 3.

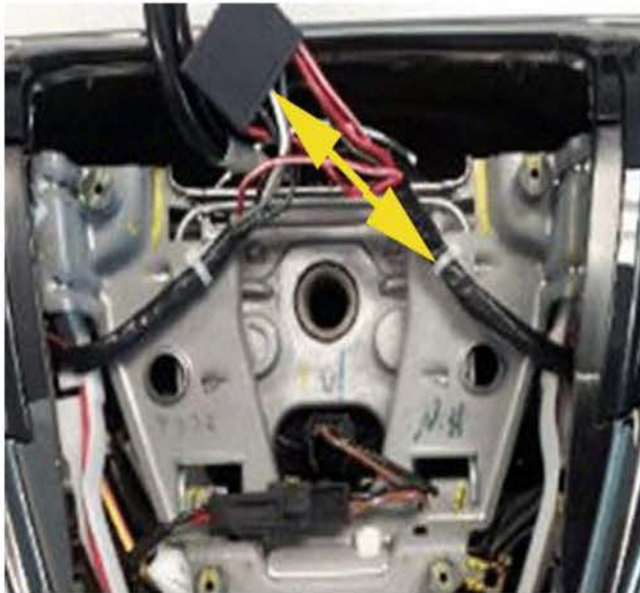
2966070

3. Disconnect the upper 10 way connector.

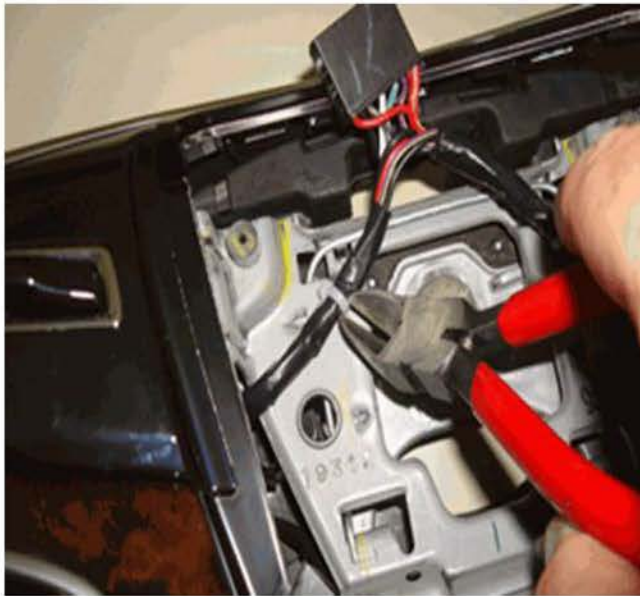
2966071

- Measure both the left side and right side harness length from the white retaining clip (wire tie) to the center of the connector (where white wire enters). The wire length should be measured from a straightened wire. The measurement should be between 50 mm and 63 mm in length for both left and right side.
- If either side measures less than 50 mm or more than 63 mm, proceed to step 4. If both sides are within the target measurement, proceed to step 5.

4. Cut the white wire tie that retains the incorrect length wire harness to the horn plate. It is not necessary to remove both clips for this step if one side has an acceptable length. Use care to not damage the harness.

Remove the wire tie retainer from the horn plate. Use care to ensure no plastic pieces of the retainer break off and drop into the steering wheel. If plastic debris falls into the steering wheel, it may cause a rattle condition.

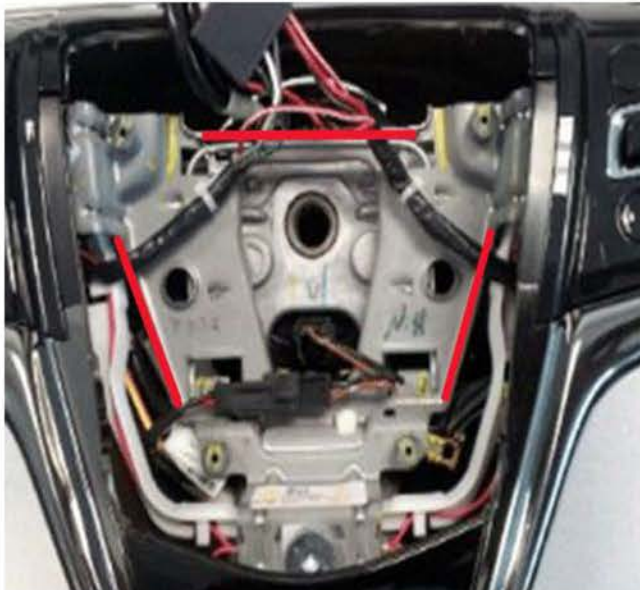
2966073

5. Carefully inspect the wires for damaged (missing) insulation. This damage is caused by the wiring making hard contact with the sharp metal edge of the stamped steel horn plate.
 - 5.1 If only the insulation is damaged, apply two light coats of *Kent Industries Liquid Vinyl Tape, Part # 99491 or the equivalent, to the wire where the insulation is nicked or missing. Proceed to step 6.
 - 5.2 If the insulation and the conductor (wire) are damaged, replace the affected harness. After the harness has been replaced, continue with step 6.

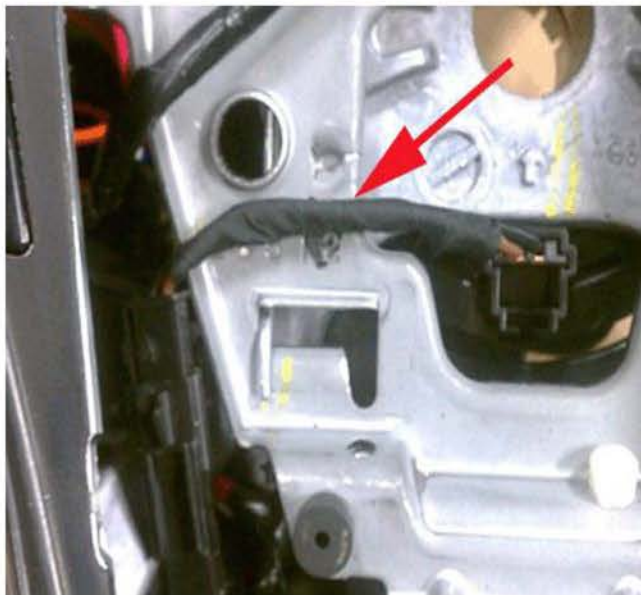
3020037

3. Inspect the heated steering wheel wiring harness for damaged insulation. Repair any damaged wire insulation using the procedure outlined in step 5 above.
4. Wrap the heated steering wheel wiring harness with protective tape Such as *Kent Industries Part # 1089482 or the equivalent, as follows:

4.1. On the clock spring side, wrap the brown and black wires as shown.

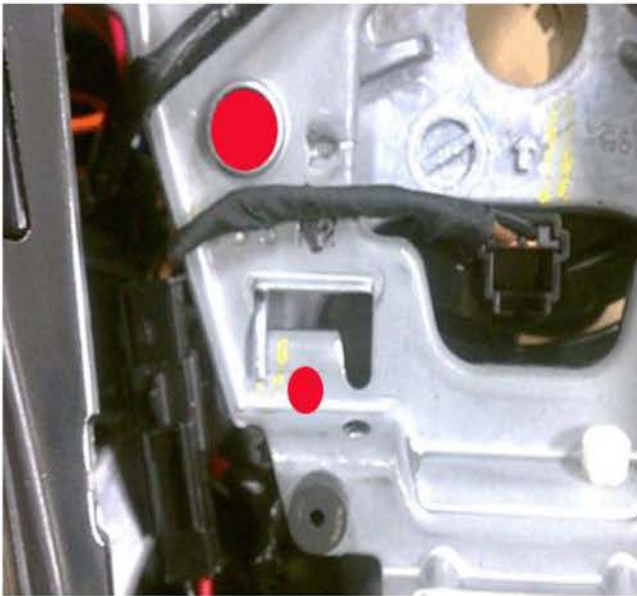
3020040

Do not re-fasten the harness to the horn plate. Ensure the harness is clear of the airbag mounting attachment points (red pinch points).

5. Position the harness as shown.
