**SUBJECT:** Service Update for Inventory and Customer Vehicles  
Starter Motor Damage Due to Positive Battery Cable and Starter Solenoid  
Terminal Contact  
Expires with Base Warranty

**MODELS:** 2013 Chevrolet Sonic  
U.S. Vehicles Only

Subject: 12289 – Service Update Bulletin  
Starter Motor Damage Due to Positive Battery Cable and Starter  
Solenoid Terminal Contact

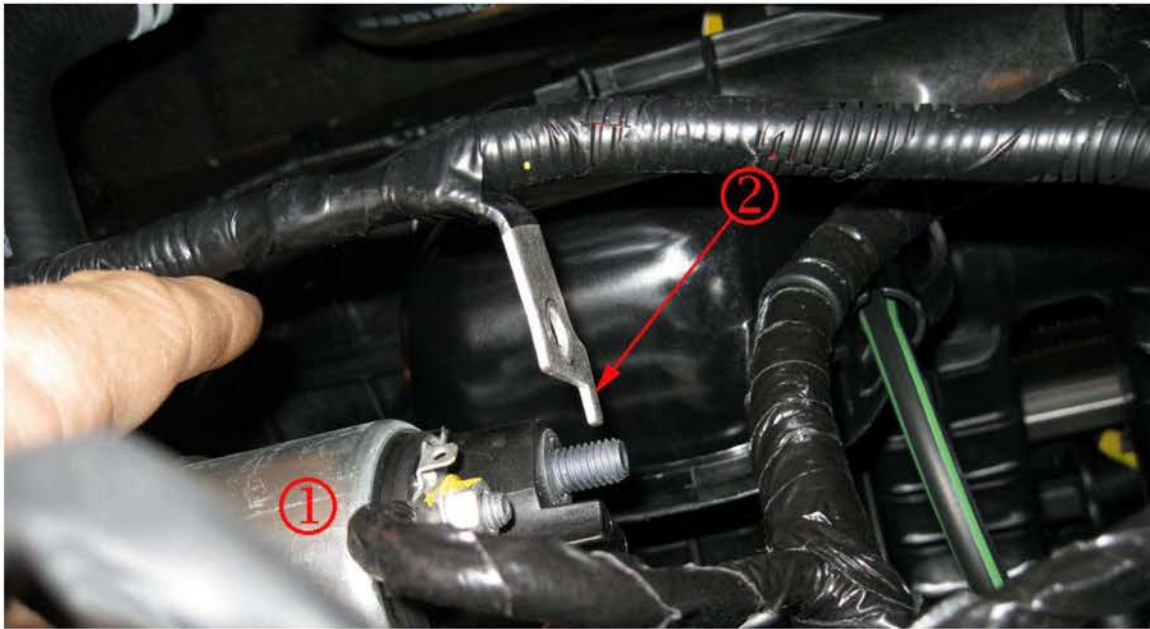
3136617

3. Locate the starter solenoid (1), positive battery cable terminal (2) and positive battery cable fastener (3).

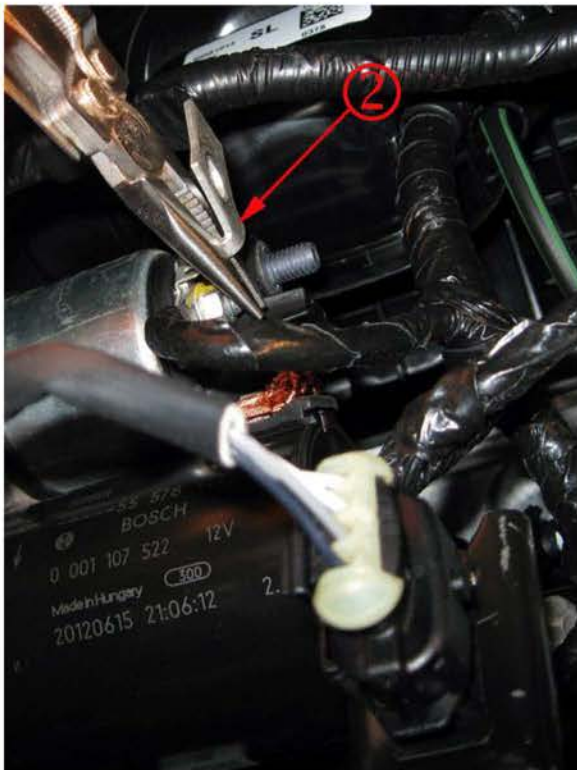
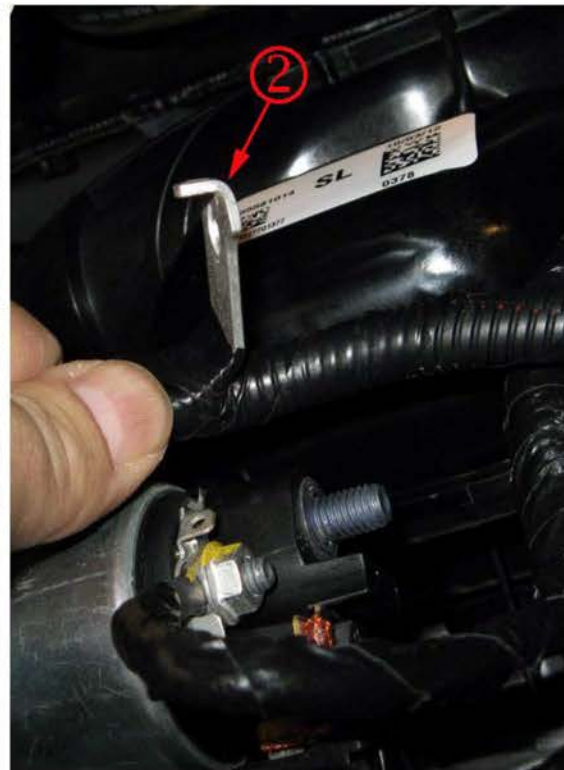
3136868

4. Remove the positive battery cable fastener and the positive battery cable terminal (2), from the starter solenoid (1).

5. Using pliers bend the positive battery cable terminal tab (2) 90 degrees inward as shown in illustration.

**Note:** Do NOT allow the battery positive cable terminal tab to rotate clockwise on the starter solenoid while tightening the battery positive cable terminal fastener. Hold the positive battery cable terminal tab down (counter clockwise) while tightening the positive battery cable terminal fastener.

6. Install the positive battery cable terminal and fastener to the starter solenoid.
7. Tighten the positive battery cable terminal fastener to 9 Nm (80 lb-in).
