Hood Opening  
Angle Insufficient  
CXU

## FSB 820-001, Hood Opening Angle Insufficient

(November 2012)

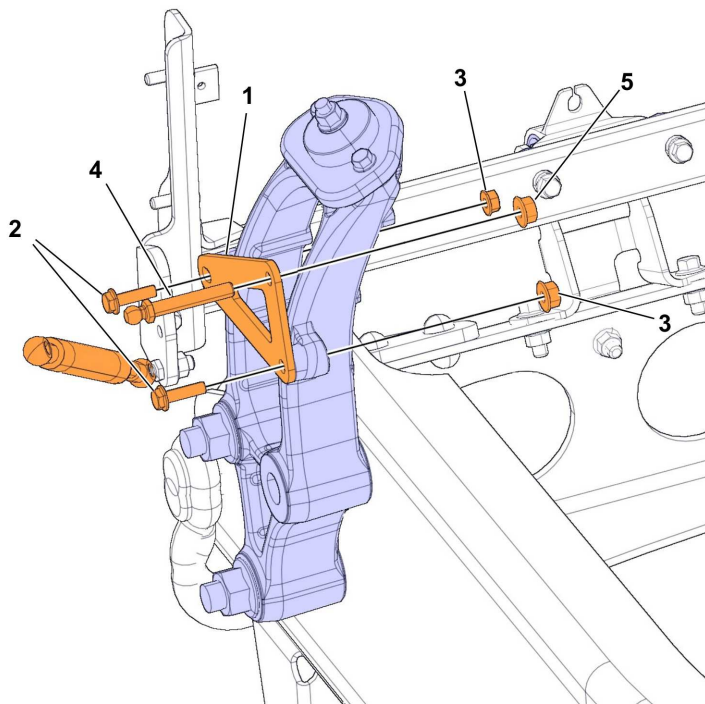
W8078009

- 1 – Bracket, Part Number 82723420
- 2 – Bolt, Part Number 990862
- 3 – Nut, Part Number 990941
- 4 – Connector, Part Number 21009167
- 5 – Existing Nut

- 1 Secure the vehicle for service by parking it on a flat level surface, applying the parking brake, chocking the rear wheel, and placing the transmission in neutral.
- 2 Disconnect all cables from the negative (ground) and positive battery terminals to prevent personal injury from electrical shock and prevent damage to electrical components.
- 3 Open the hood.
- 4 Remove the driver's side hood strut from the connector on the radiator support.
- 5 Remove the driver's side connector from the radiator support.
- 6 Install the replacement mounting bracket (part number 82723420) to the radiator support. Torque the fasteners to 48 +/- 8 Nm (35 +/- 6 ft-lb).
