Service Bulletin

PRELIMINARY INFORMATION

Subject: Retrofit Procedure for New Corded Folding Top Cover Installation to Original Design Frame

Models: 2011-2012 Chevrolet Camaro Convertible

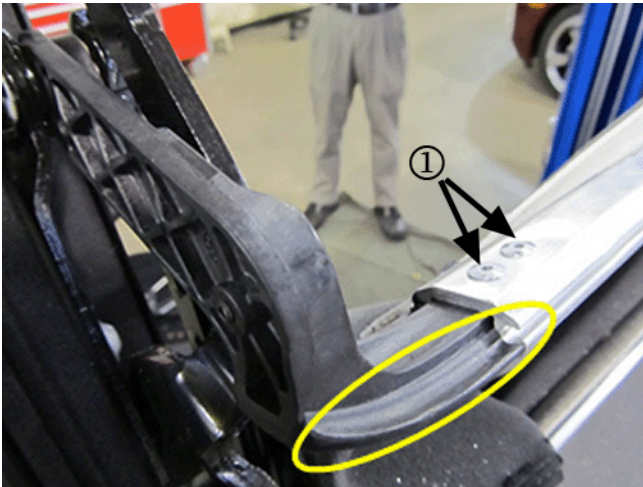
Early Design #2 Bow Bracket

Important: The #2 bow end brackets are made of plastic and will likely break/snap during removal. Two new brackets are included with the top cover replacement kit. Regardless of breakage, all early design #2 bow brackets should be replaced.

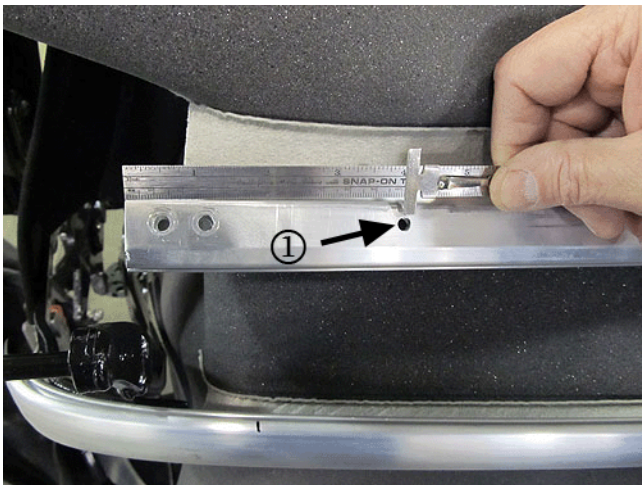
Important: The two holes added to the #2 bow should be centered on the bow and ARE NOT through holes. DO NOT drill through to the topside of the #2 bow.

11. While the #2 bow is removed, drill two 5 mm (0.197 in) holes (1) in the underside of the #2 bow. Position the holes 102 mm (4.0 in) from each end of the bow.

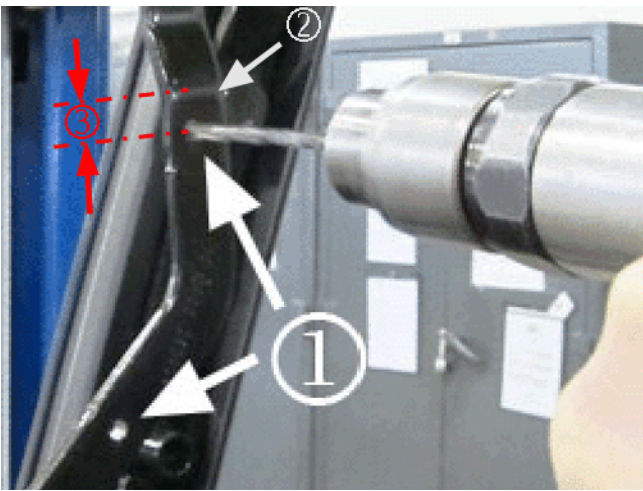
Note: Older convertible tops may be missing the upper 3.2 mm diameter hole shown in the control link above. If the hole is missing, add by drilling a new 5 mm (0.197 in) hole positioned 10 mm (.40 in) (3) from the bend radius (2). Repeat the same operation on the opposite side of the top.

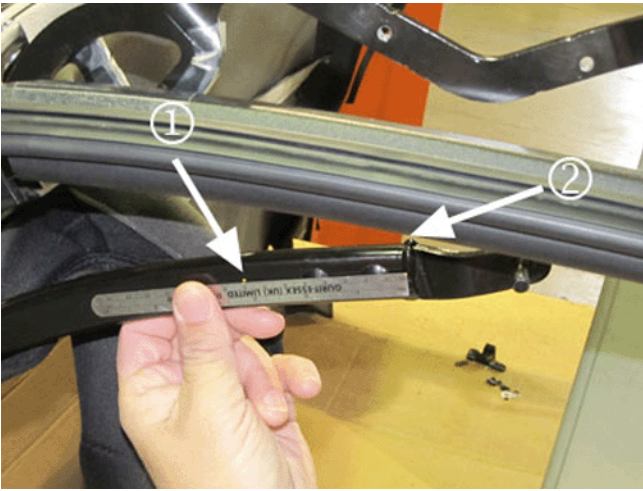
Important: The holes added to the each balance link are on the outboard side of the link and ARE NOT through holes. DO NOT drill through to the inboard side of the balance link. The right side balance link is shown in the graphic above.

14. Centered on the outboard side of the right balance link (1), drill a new 3.2 mm (0.125 in) hole, positioned 80 mm (3.15 in) from the center weld bead (2). Repeat the same operation on the opposite side.

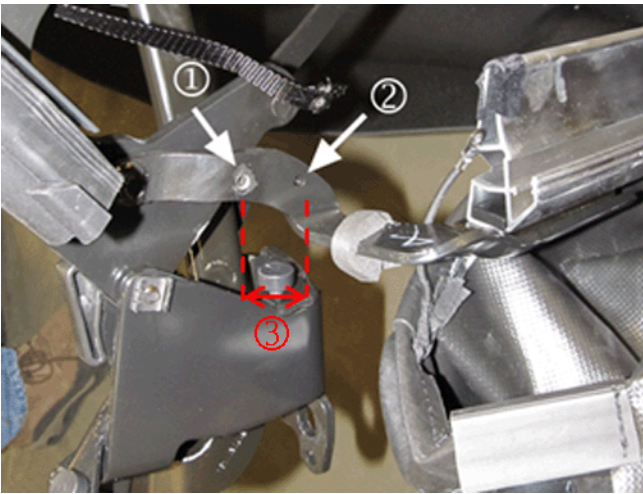
Important: The graphic above shows the left #5 bow bracket with the strap and cords removed, and also the orientation of the new hole (1) and existing hole (2) for illustration purposes only. The new hole may or may not be present and needs to be checked once the old top cover is removed. If the new hole is missing, add the 5 mm (0.197 in) hole to both the left and right #5 bow brackets.

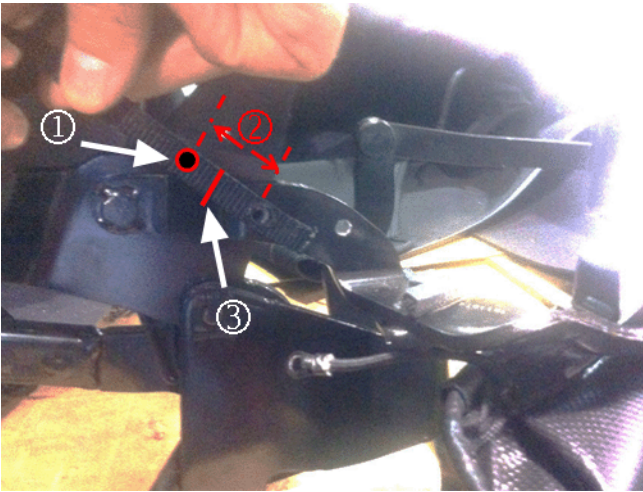
Important: The graphic above shows the headliner strap, which is attached to the 5 bow bracket AFTER the rivet was removed. If the top being retrofitted does not have a new 5 bow bracket with the new hole, then using a hot mandrel, or equivalent tool, burn a new hole (1) into the headliner strap. As shown above, locate the new hole 30 mm (1.20 in) (2) from the current location, then cut the reworked headliner strap at call out #3.

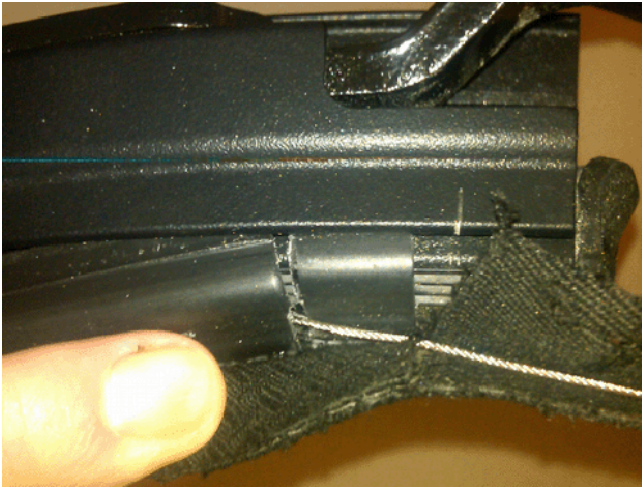
Note: The design of the top cover plastic retainer has changed slightly on the new corded top covers. The plastic retainer on the previous top covers had a slit near the end that allowed the side tension cable to pass through it as shown above.
