Service Bulletin

Subject: Excessive Water in Door, Wet Carpet After Hard Rain or Automatic Car Wash

Models: 2012-2013 Chevrolet Impala

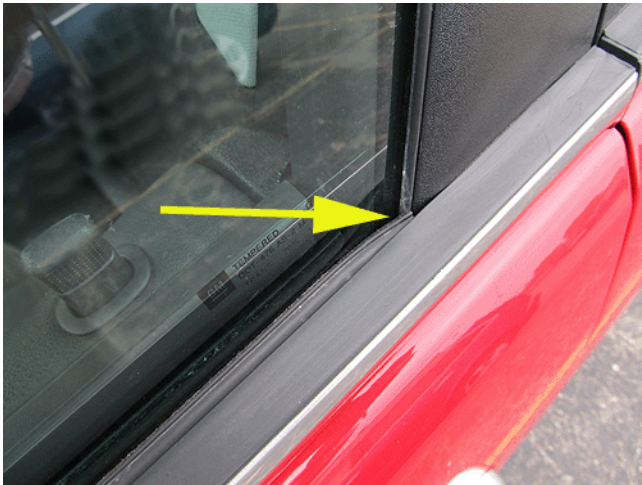
Some customers may comment that the carpet is wet or that there is excessive water in one or more of the vehicle doors. This condition is possible on all four doors. This condition occurs after a hard rainfall or the vehicle has been run through an automatic car wash.

This condition may be caused by an out of position outer window belt sealing strip (side door window belt outer sealing strip).

Using an appropriate tool, reposition the seal. Ensure it contacts the glass for the full length of the seal. Cycle the window up and down to ensure the seal stays in the correct position.
