# Service Bulletin

**Subject:** Inspection and Repair Guidelines for Dust Intrusion into Passenger Compartment

**Models:** 2010-2013 GMC Terrain

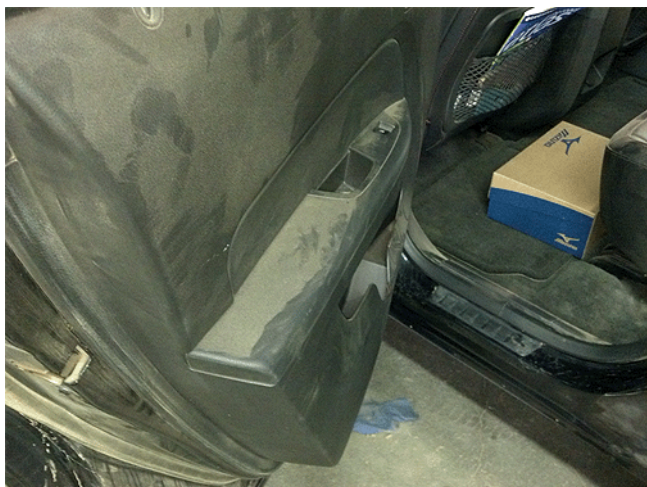
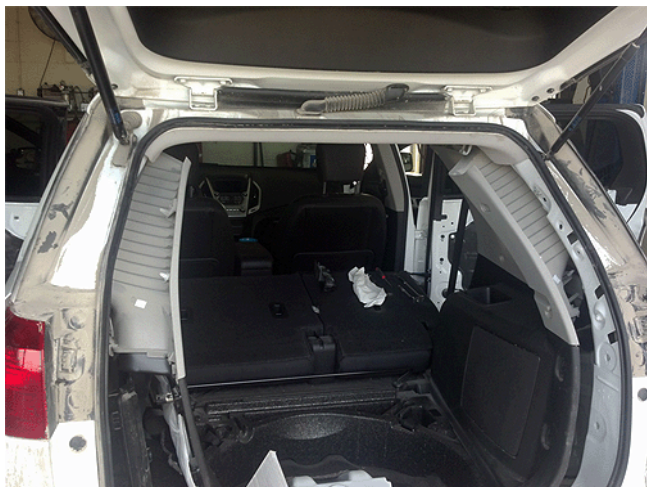
Some customers may comment that excessive dust is entering into the passenger compartment through the side doors or rear liftgate areas. This usually found to occur when the vehicle is driven in high dust areas. Examples of this condition are shown in the graphics below.

The cause of this condition may be that the dust/debris is working past the side door or liftgate sealing surfaces.

Once the condition is verified, look for evidence of any visual dust flow or leak path at the side doors or the liftgate area of the vehicle. This leak path will help designate the direction the repair should take.

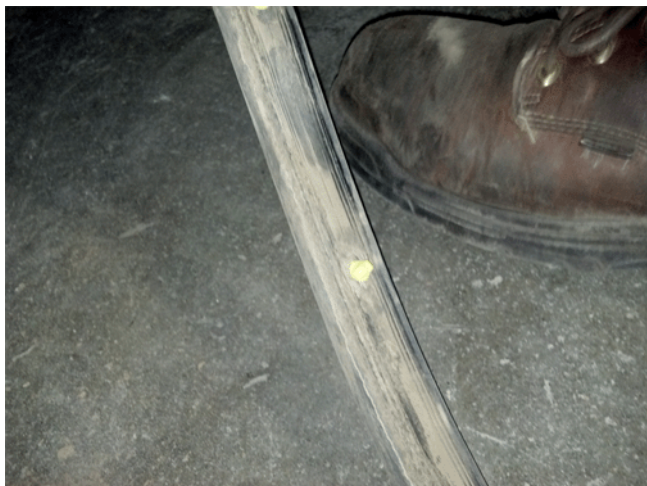
**Note:** A vehicle will sometimes show evidence of dirt/dust being pulled past the backside of the rocker moldings as shown above. A double-sided tape is added to the moldings to help eliminate this condition.

1. In extreme cases where the passenger compartment is so dirty that an obvious dust leak path is not evident, we recommend detailing the vehicle, then road testing the vehicle to try and duplicate the condition.
2. If a dust leak path is evident at the side door(s), adjust the affected door ensuring a uniform compression of the door seal to the body and complete the following steps:

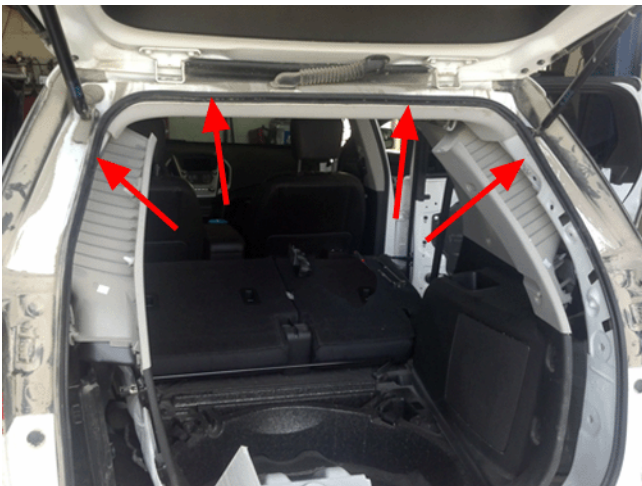
- 3.2.** Inspect the upper pinch weld flange on the body side of the gate to ensure it is perpendicular to the liftgate inner surface. The liftgate seal should have uniform compression around the complete perimeter of the seal.

- 3.3. If the pinch weld is not perpendicular, remove the liftgate seal. Refer to Liftgate Weatherstrip Replacement in SI. Inspect the seal for any deformations or damage and replace as appropriate.
- 3.4. Clean the seal mounting area with 3M™ General Purpose Adhesive Cleaner P/N 08984, or equivalent.
