Bulletin No.: PI0842

# Service Bulletin

**Subject:** Trunk Trim Panel Below Rear Package Shelf Loose/Sagging /Bowing at Rear

**Models:** 2013 Cadillac XTS

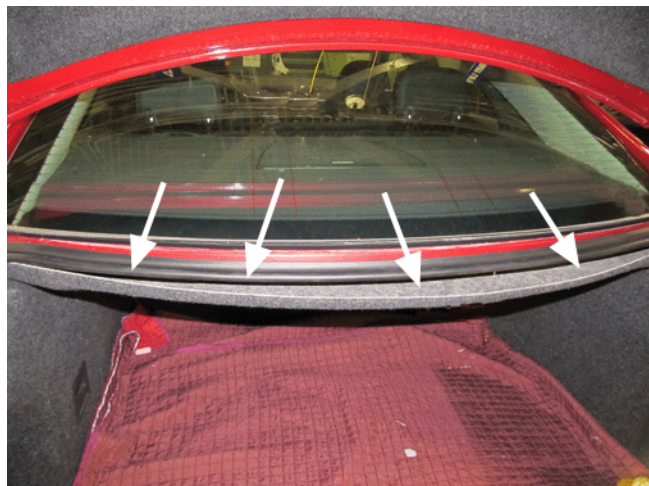
Some customers may comment that the trunk trim panel below the rear package shelf is loose, sagging or bowing at the rear. The cause of this condition may be that the trim panel may have a loose interface to the rear package shelf underside sheet metal.
