Service Bulletin

Bulletin No.: 10-05-23-001C

Subject: Brake Induced Pulsation/Vibration Felt in Steering Wheel, Rumble Noise from Underbody During Downhill Descent (Verify Condition and Replace Front Brake Pads)

Models: 2008 Chevrolet Silverado Light Duty (LD)
2008 GMC Sierra Light Duty (LD)
2nd-Design Only – w/ Pad Spreading Spring Clips (Refer to PIT4611 for Design Identification)
Equipped with Disc/Drum Brakes (RPO JF3) and Stabilitrak (RPO JL4)
2009-2013 Chevrolet Silverado Light Duty (LD)
2009-2013 GMC Sierra Light Duty (LD)
Equipped with Disc/Drum Brakes (RPO JF3 or JF7) and Stabilitrak (RPO JL4)

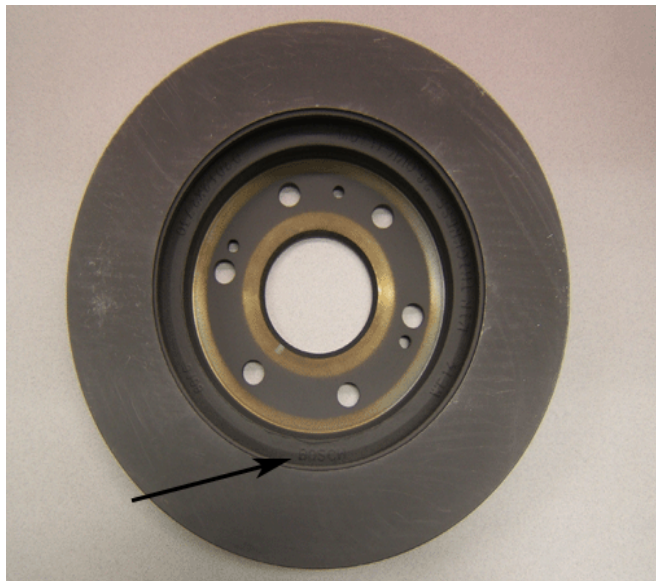
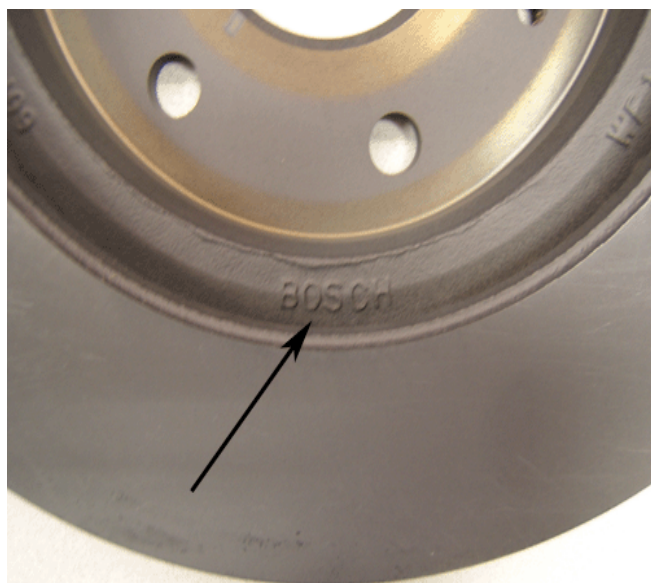
- Inspect the back side of the rotor for the Bosch Logo. If the Bosch logo IS NOT present, replace with OEM GM rotors, P/N 25819670.
2. Inspect the front brake rotors for Assembled Lateral Runout (LRO) and thickness variation. Follow SI procedures.
 3. Inspect the front brake rotors for minimum thickness. Follow SI procedures.
 4. If the rotors are within specifications, DO NOT refinish or replace the rotors.
 5. If the rotors are out of specifications, refinish the rotors on a qualified lathe, or replace the rotors as appropriate. Follow SI procedures.
- Note:** To prevent a noise concern, follow the brake pad insulator preparation and seating instructions as referenced in Front Brake Pad Replacement (1500) in SI.
6. Install the specified front pad kit, GM P/N 25910432. Follow SI procedures.
 7. Ensure that the condition has been eliminated under the same conditions.
