Program Bulletin

CUSTOMER SATISFACTION PROGRAM

SUBJECT: Transmission Dipstick Tube Fracture

MODELS: 2010-2011 Cadillac Escalade, Escalade ESV, Escalade EXT
2010-2011 Chevrolet Avalanche, Silverado, Suburban, Tahoe
2010-2011 GMC Sierra, Yukon, Yukon XL
Equipped with Active Fuel Management

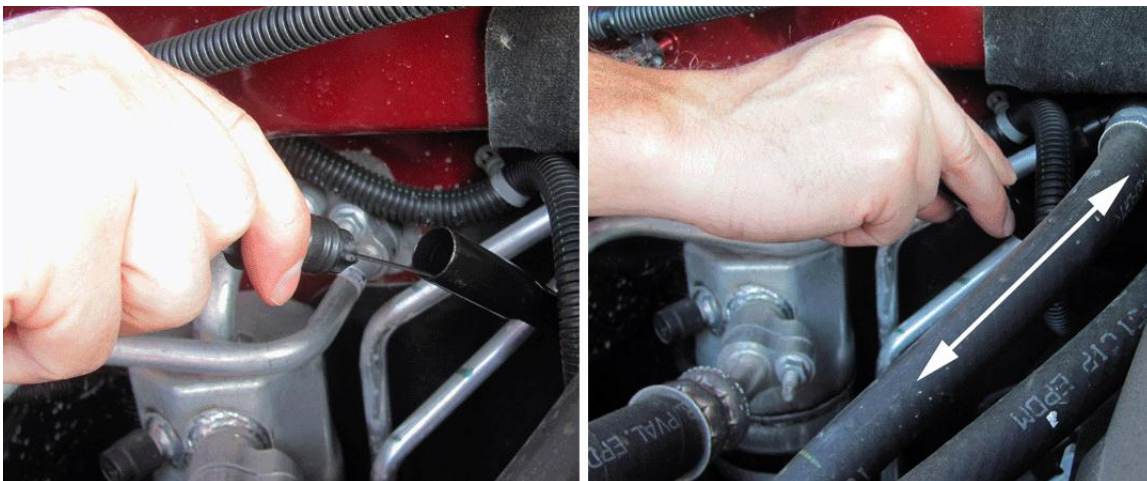
2906255

2. Remove dipstick from transmission filler tube.

Note: If required, use a step to aid in grasping the transmission filler tube correctly.

3. Grasp the transmission filler tube with your thumb and first two fingers of your right hand. Your thumb should be on the passenger side of the transmission filler tube and parallel to the filler tube.

4. Using only your thumb and the first two fingers of your right hand, force the transmission filler tube toward the driver's seating position and then back to the passenger's front wheel two times.

5. Determine if the transmission filler tube is damaged. An undamaged transmission filler tube will move less than two inches and spring back to its original position, while a damaged transmission filler tube will move greater than two inches and will not spring back to its original position. A damaged transmission filler tube will likely crack during this inspection.

- If the transmission filler tube is not damaged, proceed to Step 6.
 - If the transmission filler tube is damaged, replace the transmission filler tube. Refer to *Transmission Fluid Filler Tube and Seal Replacement* in SI.

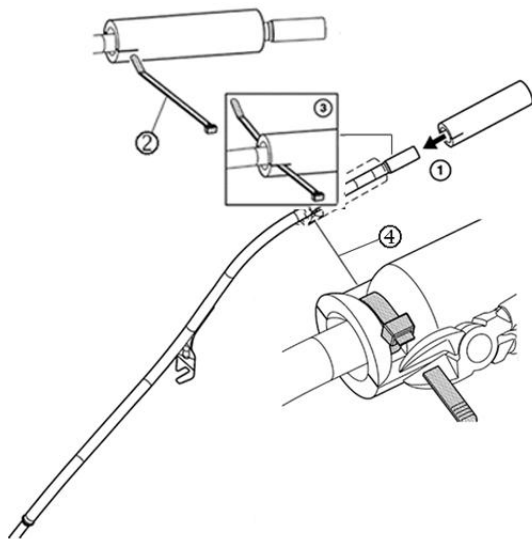
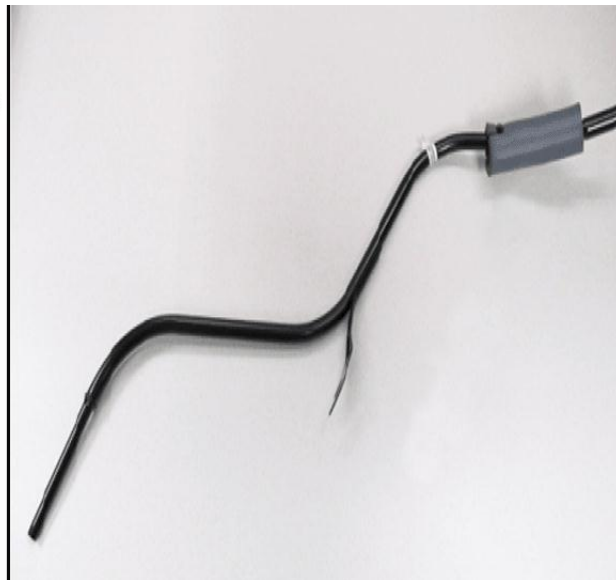
2906258

Note: The tie strap threads between the fill tube and half the foam damper using the slot in the sleeve. This is secured to the top half of the tube, leaving the lower half of the damper free.

7. Install a foam damper (sleeve) on the upper end of the transmission filler tube using a tie strap. Refer to illustration.
8. Install transmission dipstick.
9. Close hood.
