SUBJECT: Service Update for Inventory and Customer Vehicles
Rear Suspension Toe Link Jam Nut Low Torque
Expires with Base Warranty

MODELS: 2013 Cadillac CTS

Subject: 12256 – Service Update Bulletin
Rear Suspension Toe Link Jam Nut Low Torque

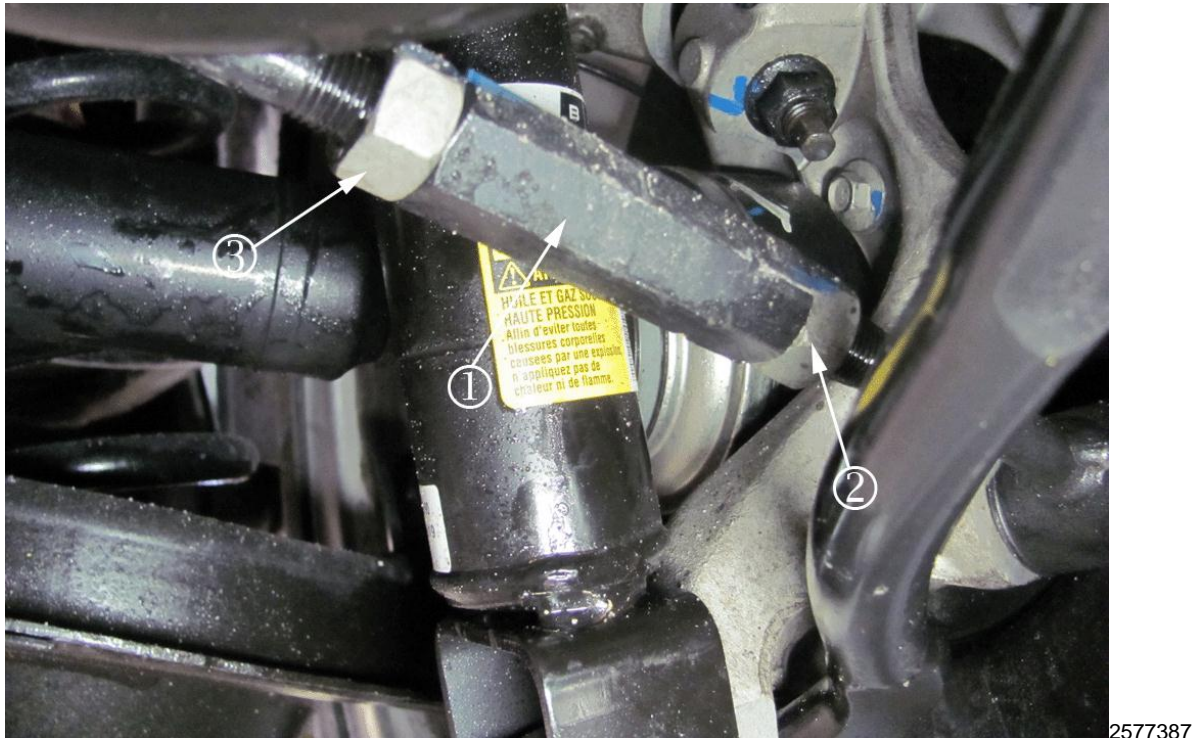
The Toe Link Assembly Includes a (1) Rear Suspension Adjustment Link, (2) Outside Jam Nut, (3) Inside Jam Nut and Inside and Outside Toe Link Rods.

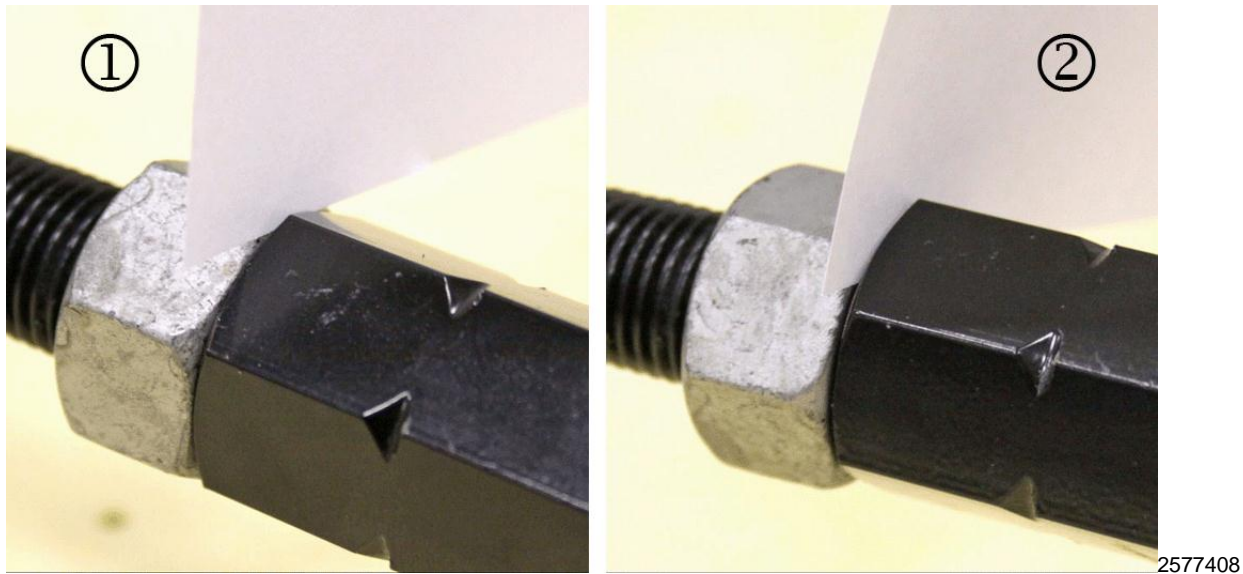
(1) Paper does NOT fit between jam nut and rear suspension adjustment link.

(2) Paper fits between jam nut and rear suspension adjustment link.

3. Inspect the toe link assembly for loosened jam nuts. In addition, inspect for looseness in the toe link assembly by grasping the adjuster link using a pull up and pull down method. Perform these procedures on both the rear driver's and passenger's side toe link assembly.
 - If a piece of paper fits between either of the two jam nuts and rear suspension adjustment link (2), proceed to Step 4 and refer to *Rear Toe Adjustment* in SI.
 - If the toe link assembly has any kind of looseness, proceed to Step 4 and refer to *Rear Toe Adjustment* in SI.
 - If a piece of paper does not fit between either of the two jam nuts and rear suspension adjustment link (1), proceed to Step 5.
4. Perform an alignment. Inspect and adjust the rear toe. Refer to *Rear Toe Adjustment* in SI.

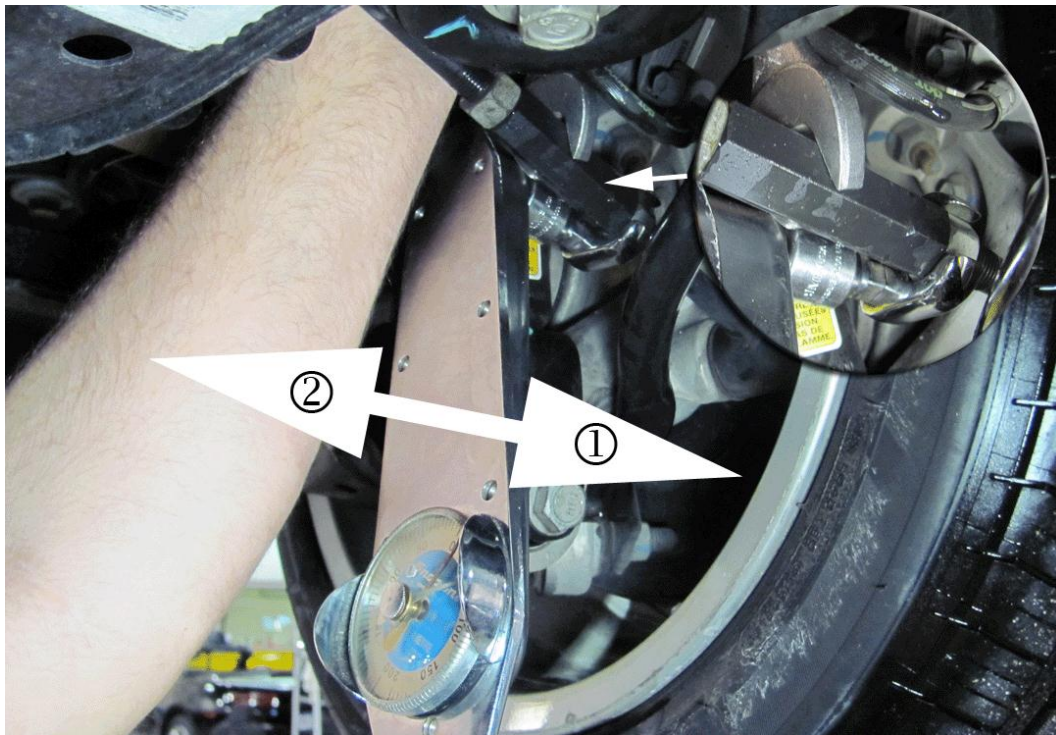
2577413

(1) Direction of tightening force (rearward) on the Driver's Side Rear Suspension Adjustment Link Jam Nuts (2) Direction of tightening force (forward) on the Passenger's Side Rear Suspension Adjustment Link Jam Nuts

Caution: To obtain an accurate torque reading, a torque wrench, 21mm (13/16 in) crow's foot wrench, and a 21mm (13/16 in) open end wrench are required. Hold the rear suspension adjustment link with a 21 mm (13/16 in) open end wrench while tightening the jam nuts.

- Apply a rearward (rear of vehicle) tightening force to the torque wrench to properly tighten the jam nuts on the driver's side of the vehicle.
- Apply a forward (front of vehicle) tightening force to the torque wrench to properly tighten the jam nuts on the passenger's side of the vehicle.

Note: Use 90 N·m (66 lb-ft) to tighten the jam nuts. Do NOT use the torque specification provided in *Rear Toe Adjustment* in SI for repaired toe link assemblies. This applies to vehicles in this field action only. **Tighten all four (4) jam nuts to 90 N·m (66 lb-ft).**

5. Hold the rear suspension adjustment link with a 21 mm (13/16 in) open end wrench and tighten the jam nuts to **90 N·m (66 lb-ft)**.
6. Lower the vehicle. Refer to *Lifting and Jacking the Vehicle* in SI.
