GROUP Electrical	MODEL 2013MY Rio (UB)
NUMBER 050	DATE November 2012

TECHNICAL SERVICE BULLETIN

SUBJECT: SERVICE ACTION: AVN SOFTWARE UPGRADE (SA133)

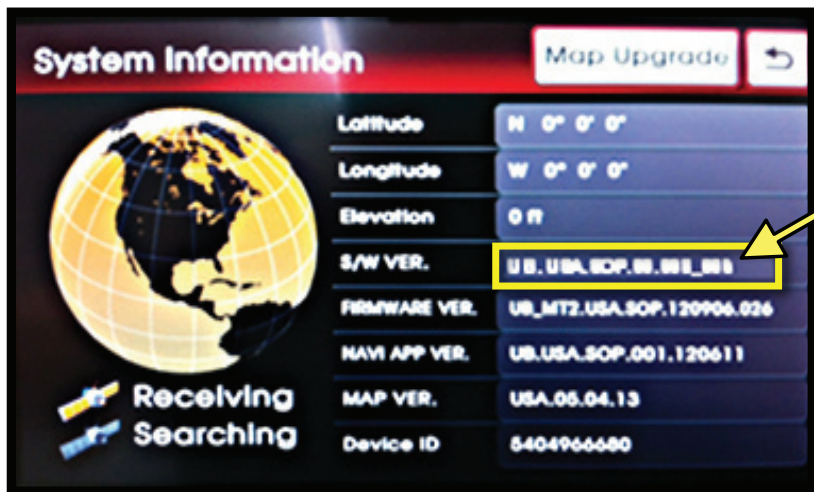
This bulletin describes the procedure to update the navigation system software and modify the phone pairing logic in 2013MY Rio vehicles, with navigation system (AVN) and manual transmission, produced From June 12, 2012 to Aug. 29, 2012. Verify navigation system software version by referring to the table below; then follow the procedure outlined in this TSB to update the navigation system. Kia is requesting the completion of this Service Action on all affected vehicles in dealer stock prior to delivery. Before conducting procedure, verify that the vehicle is included in the list of the affected VINs.

OLD S/W VERSION:	UB.USA.SOP.00.008_006
NEW S/W VERSION:	UB.USA.SOP.00.014_MT2

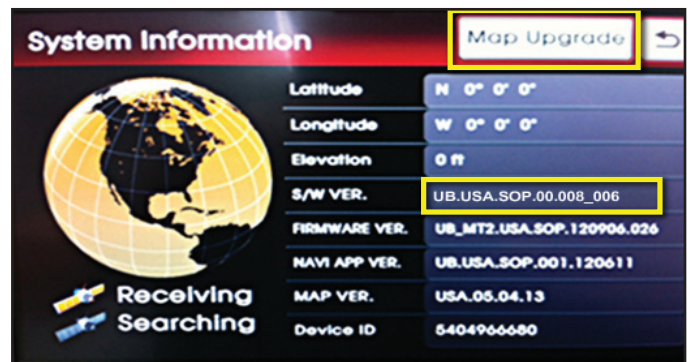
Verify current software version is **“UB.USA.SOP.00.008_006”**

14. Push **“Map Upgrade”** button on the screen.

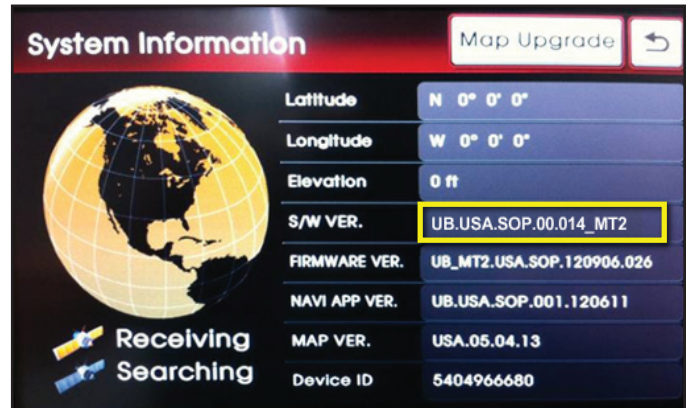
22. Verify new software version is **UB.USA.SOP.00.014_MT2.**

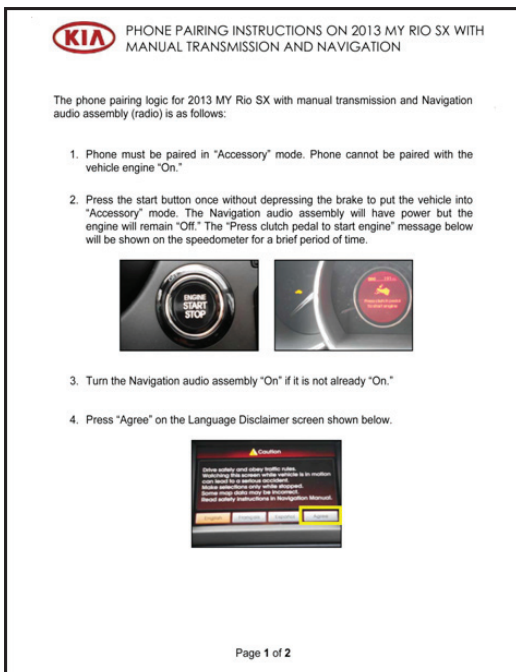
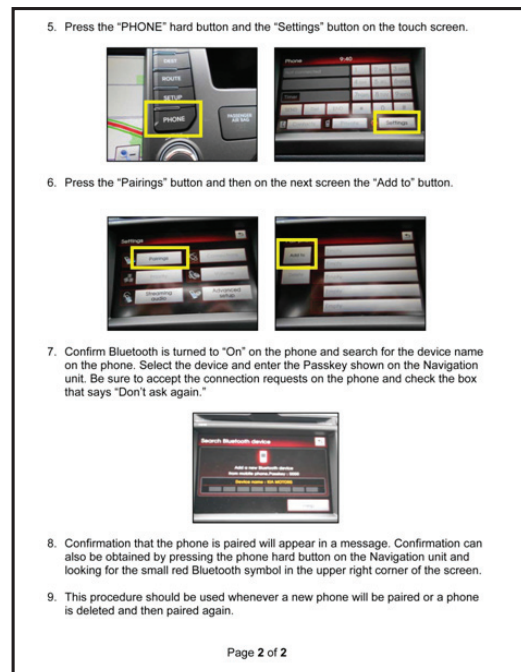
23. Check the interior of the vehicle (i.e. glove compartment, center console, etc.) for phone pairing instructions, as shown below. Any instructions found should be removed from the vehicle and discarded as this update will modify the phone pairing logic to match the information in the owner's manual.
