GROUP Electrical	MODEL Optima (QF) 2013MY
	NUMBER 045	DATE November 2012
TECHNICAL SERVICE BULLETIN		
SUBJECT: SERVICE ACTION: UVO SOFTWARE UPGRADE (SA136)

SUBJECT: SERVICE ACTION: OPTIMA (QF) UVO SOFTWARE UPGRADE (SA136)

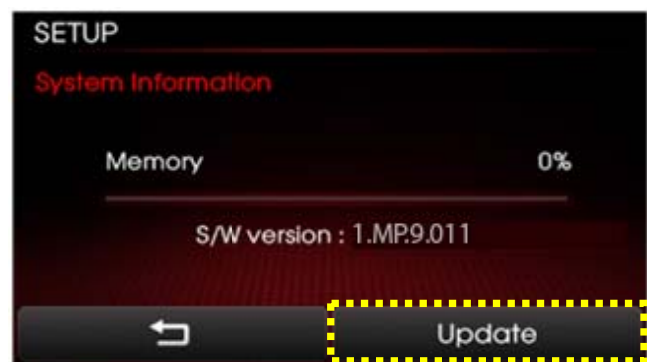
- 12a. Verify the current S/W version (1.MP.9.011) as shown in the image.

- 12b. Touch “**Update**” button on screen.
