GROUP  
General

MODEL  
2011 Sportage (SL)

NUMBER  
040 [Rev 1, 12/11/12]

SERVICE ACTION: SPORTAGE (SL) AVN SOFTWARE UPGRADE (SA050)

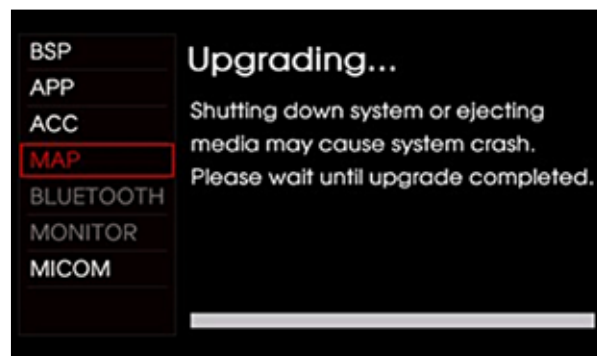
This bulletin provides information relating to a very small amount of 2011 Sportage (SL) vehicles, equipped with navigation, built from the start of production to July 22, 2010. These vehicles may exhibit announcement voice volume that is lower than normal as compared to other modes when pressing the MAP VOICE BUTTON or the TALK BUTTON in FM/AM mode. To correct this condition, an upgrade is available for the Audio/Navigation system. To properly perform the software upgrade, follow the Service Procedure outlined in the bulletin.

*Software  
Upgrade  
for Audio/  
Navigation  
System*
