## SERVICE BULLETIN

**APPLICABILITY:** 2013MY BRZ

**NUMBER:** 09-54-12

**SUBJECT:** High-Pitched “Chirp,” “Squeak” or “Cricket”  
 Sound from the Engine

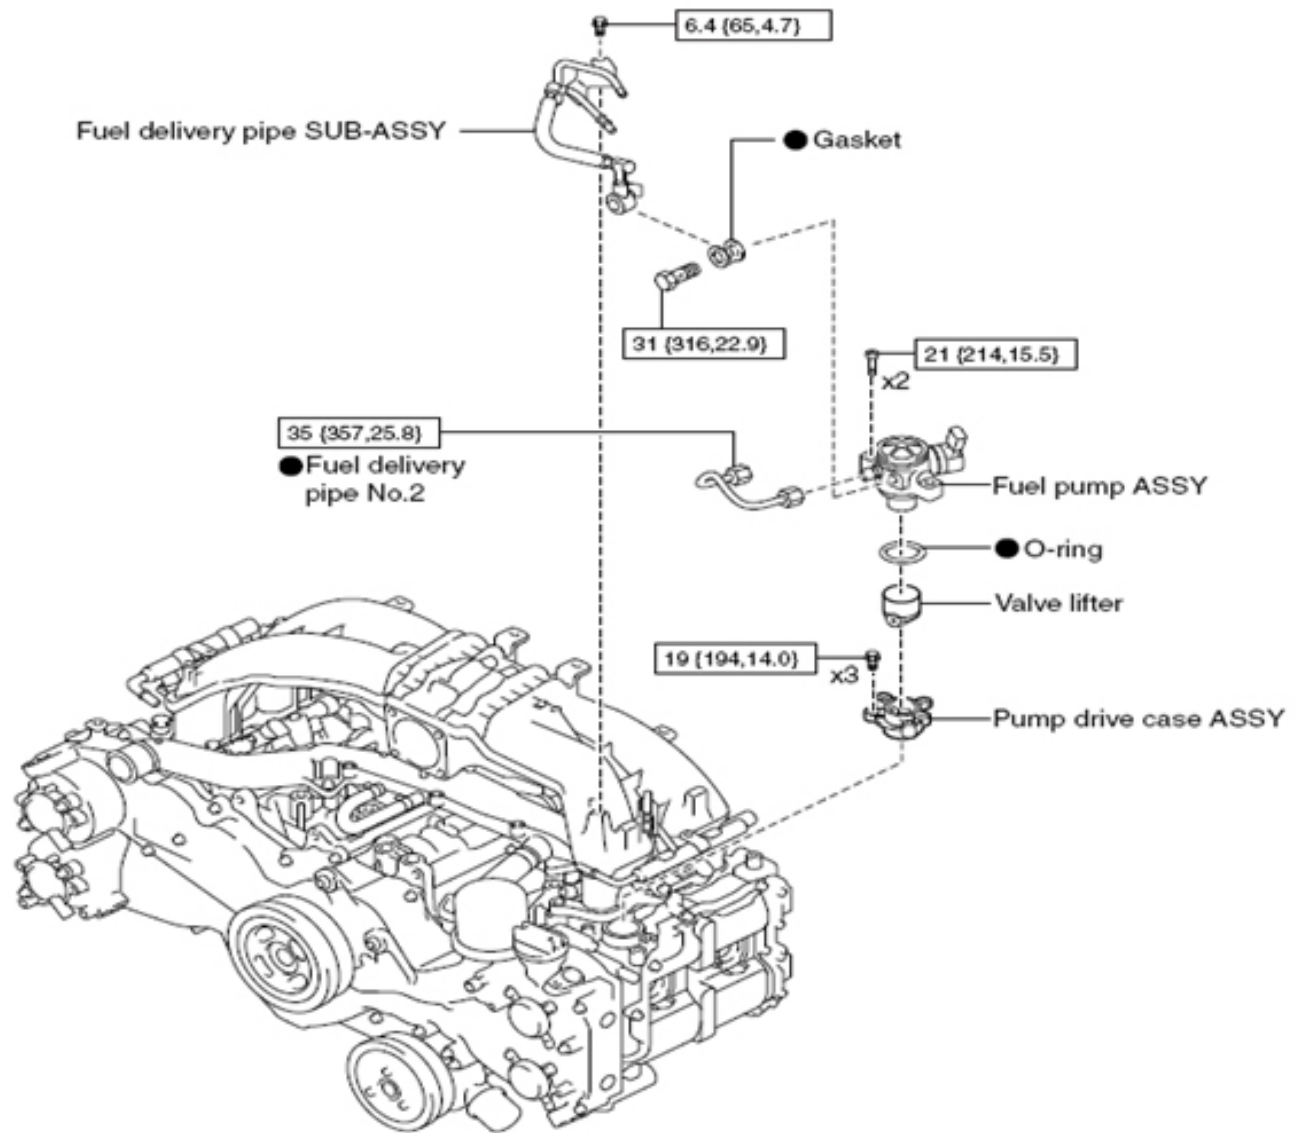
## PART INFORMATION

- Items indicated in the exploded view with a ● are “non-reusable” and **MUST** be replaced.
- The o-ring is included with the fuel pump assembly.
- Part numbers and quantity required to complete the procedure are listed below.

**IMPORTANT:** Always follow the tightening torque specifications as indicated in the applicable Service Manual (and the exploded view diagram on pg. 2) during re-assembly.
