SERVICE BULLETIN

APPLICABILITY: 2012MY Forester, Impreza and WRX Models

15-155-12R

SUBJECT: Fujitsu Ten (F10) Audio/Navigation Unit SD Card Exchange Information

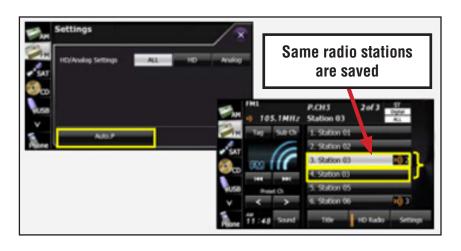
Condition 1:

When the "Auto. P" button is pressed on the "Settings" screen in AM or FM mode, a small "pop" noise is heard through the speakers. This condition may occur when the same radio station preset is saved twice in the "Preset" memory.

Speakers make a small "pop" noise

If the same FM preset is saved twice, change one to a different station

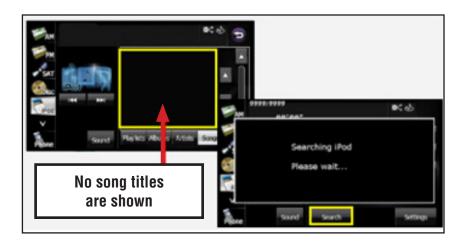
Condition 2:

Song titles are not shown in iPod mode. This condition may occur when the "Search" button on the "iPod Main" screen is pressed while the "Searching iPod Please wait..." message is displayed.

Searching iPod starts. Song lists will not be displayed if "Search" button is pressed again before the function is completed

No song titles are shown

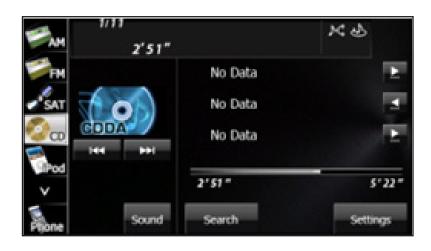
Condition 3:

CD playback is delayed for approximately 10 seconds after loading a CD or the CD mode is selected.

CD playback takes about 10 seconds to start

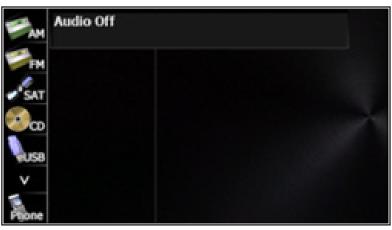
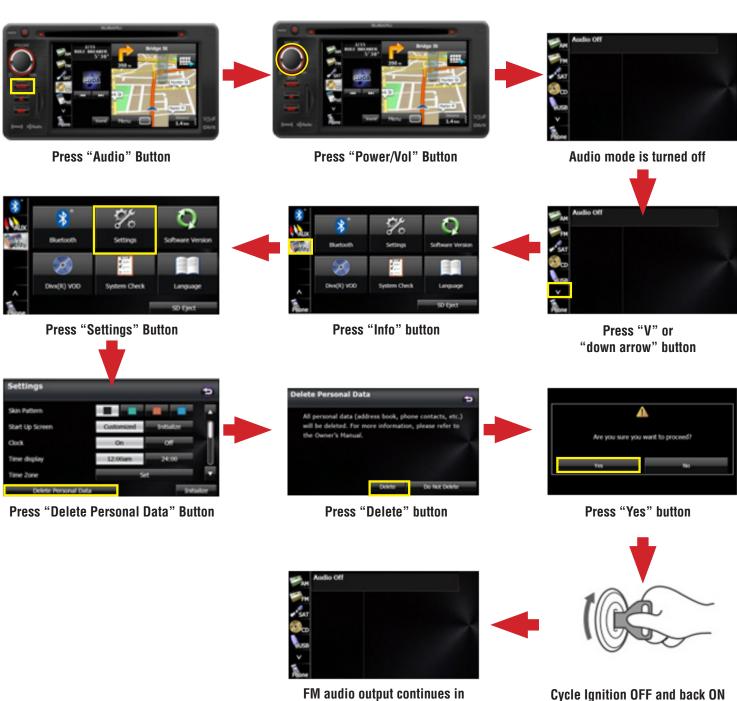
Condition 4:

FM radio can still be heard even if the audio unit is in "Audio Off" mode. This condition happens after "Delete Personal Data" button is pressed and cycling the ignition key off and back on again.

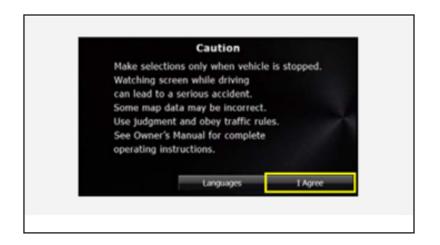
Condition 5:

"I Agree" button cannot be selected on the Caution screen.

"I Agree" button does not work

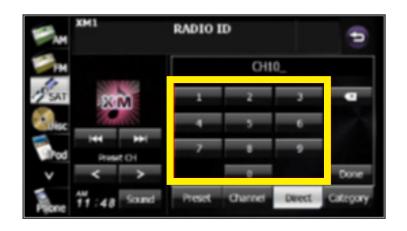
Condition 6:

In XM mode, the keypad appears normal but is inoperative while the vehicle is in motion. Once the vehicle is stopped, the keypad operates normally.

Although the keypad appears to be functional (not grayed-out), it does not operate unless the vehicle is stopped.

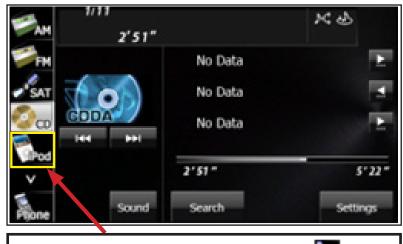
Condition 7:

USB Flash Memory device is not recognized.

Display does not change to USB icon.

USB memory is not recognized.
