SERVICE BULLETIN

APPLICABILITY: 2013MY BRZ

NUMBER: 02-137-12

SUBJECT: DTCs P0017 and P0019

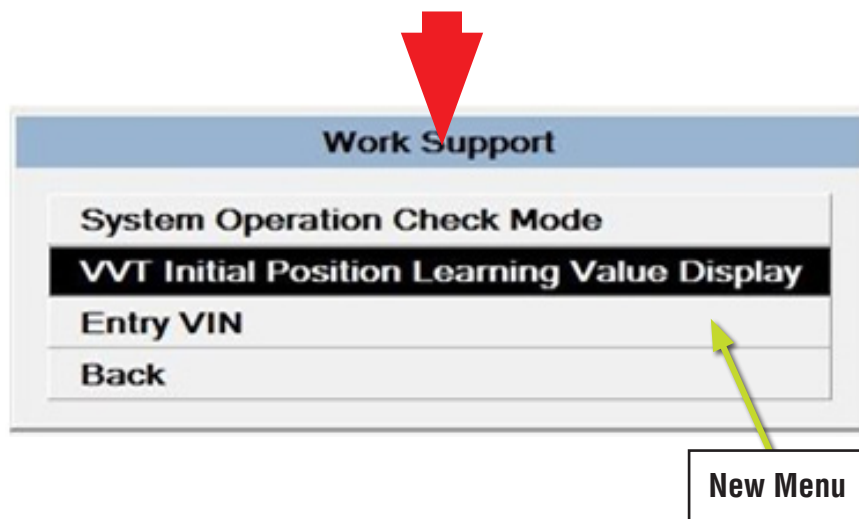
Item	Value	Unit	Maximum	Minimum	Average
<input type="checkbox"/> VVT Initial Position Learning Value #1	60.97	*FR	60.97	60.97	60.97
<input type="checkbox"/> VVT Initial Position Learning Value #2	59.89	*FR	59.89	59.89	59.89
<input type="checkbox"/> VVT Ex Initial Position Learning Value #1	88.60	*FR	88.60	88.60	88.60
<input type="checkbox"/> VVT Ex Initial Position Learning Value #2	87.97	*FR	87.97	87.97	87.97

NOTE:
The DTCs in this bulletin are only applicable to the EXHAUST (Ex) values #1 and #2

SPECIFIED CAM ANGLE LIMITS (Learning Values)	DEGREES	
	Minimum	Maximum
Exhaust	85	95

- After reviewing the data, if the values are within the specified limits, **REPROGRAM** the ECM.
- After reviewing the data, if the values are outside the specified limits, **REPLACE** the ECM.
- **IMPORTANT:** After ECM replacement, the Calibration Identification (CID) number of the ECM must be verified to be the latest version available.
- After reprogramming or replacement of the ECM is completed, road test the vehicle to confirm no DTCs reset before returning the vehicle to the customer.
