SERVICE BULLETIN

INTRODUCTION

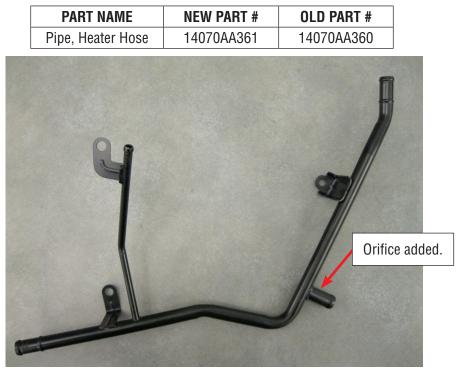
PART INFORMATION

The slight variations can be contributed to owner driving patterns. As an example, how long a vehicle is permitted to warm up, heater use during cold or hot engine temperatures, etc. An air pocket within the coolant system can also cause the code to set. A countermeasure heater hose pipe is now available which contains an orifice, designed to regulate coolant flow past the coolant temperature sensor.

The heater hose pipe is located under the intake manifold attached by 3 bolts. Refer to the applicable service manual for replacement.

Note: When refilling the coolant system make sure to follow the steps listed in the service manual to insure all air is purged from the coolant system, if not P0128 can be set again in memory.
