ARTICLES CONTAINED IN THIS ISSUE

ADDITION TO PDI PROCEDURE FOR 2013 IMPREZA AND XV CROSSTREK™

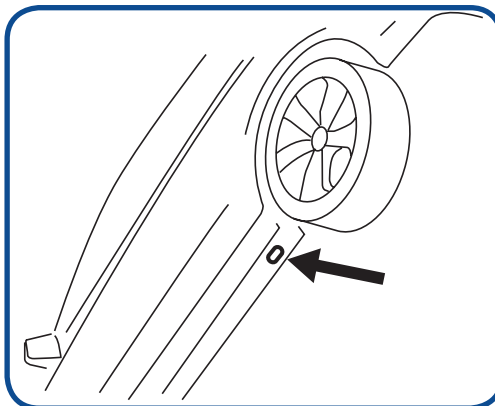
Be advised, the rubber tie-down hole plugs you are used to seeing and installing on BRZ models during PDI will be included and require installation into 2013MY Impreza and XV Crosstrek models. Currently, the timing and / or VIN break information for this change has not been finalized, but we can

report that you will start seeing the plugs included with the tool kit on these models in the near future. The Service Manual will also be updated with this change accordingly.

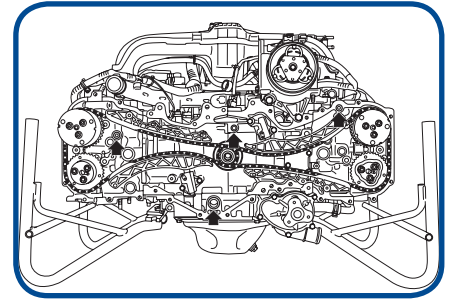
02 FRONT CHAIN COVER OIL LEAKS

When sealing a front timing chain cover to repair an engine oil leak, it is not necessary to replace the oil filter to perform the repair.

We have noticed an increase of claims charging out oil filters when resealing front chain covers.

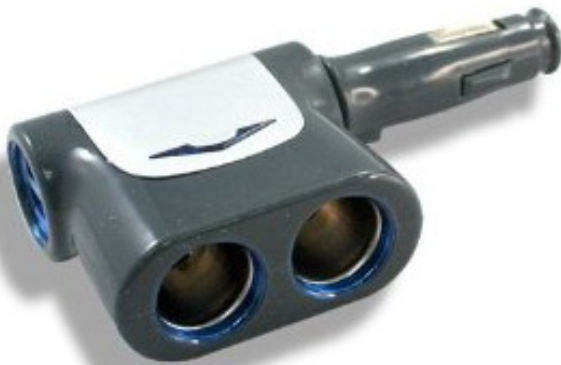
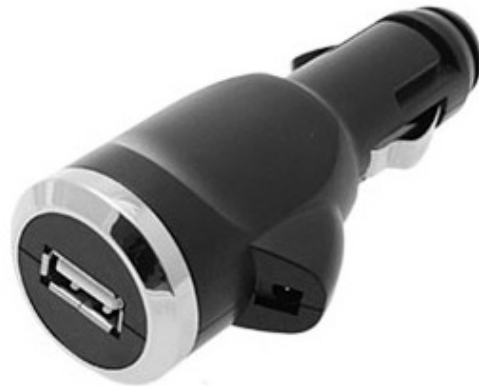
07 ODS CODE 29 OR 37, ELECTRICAL DEVICES AND AIR BAG SYSTEMS

Should you encounter a 2010-13MY Legacy or Outback with a code 29 (ODS Failure), 37 (Buckle switch RH failure) or a combination of the two codes, check to see if the customer is using a low-quality aftermarket phone charger or power splitting device in either of the power plugs. Several cases of these codes have been traced back to low-quality accessories being plugged into the power outlets causing electrical or radio frequency interference with the ODS module. Removal of the accessories usually eliminates the condition allowing the DTCs to be cleared. If the condition persists after the removal of the devices, proceed as usual with diagnostics.

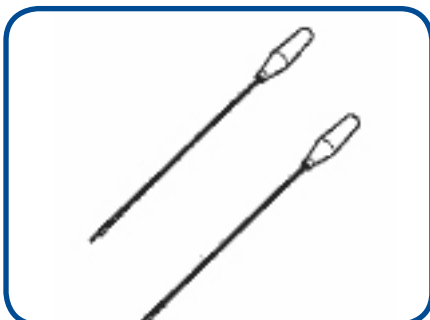
14 POWER STEERING SYSTEM TEST HARNESS PROBE

When performing diagnostic steps for DTCs related to the Electric Power Steering System on the 2012 and 2013 Impreza, some flow charts mention using a tester and test harness. The test harness being referred to is actually a set of probes used for checking smaller connector pins during diagnosis. In the General Description section of the Service Manual for the Power Assisted Steering System Diagnostics, the special probe tool is listed. The part number is 34199AG100 (Special Tool Harness).

All probing of wires should always be done at the ECM. Always make sure your vehicle's battery is fully charged.

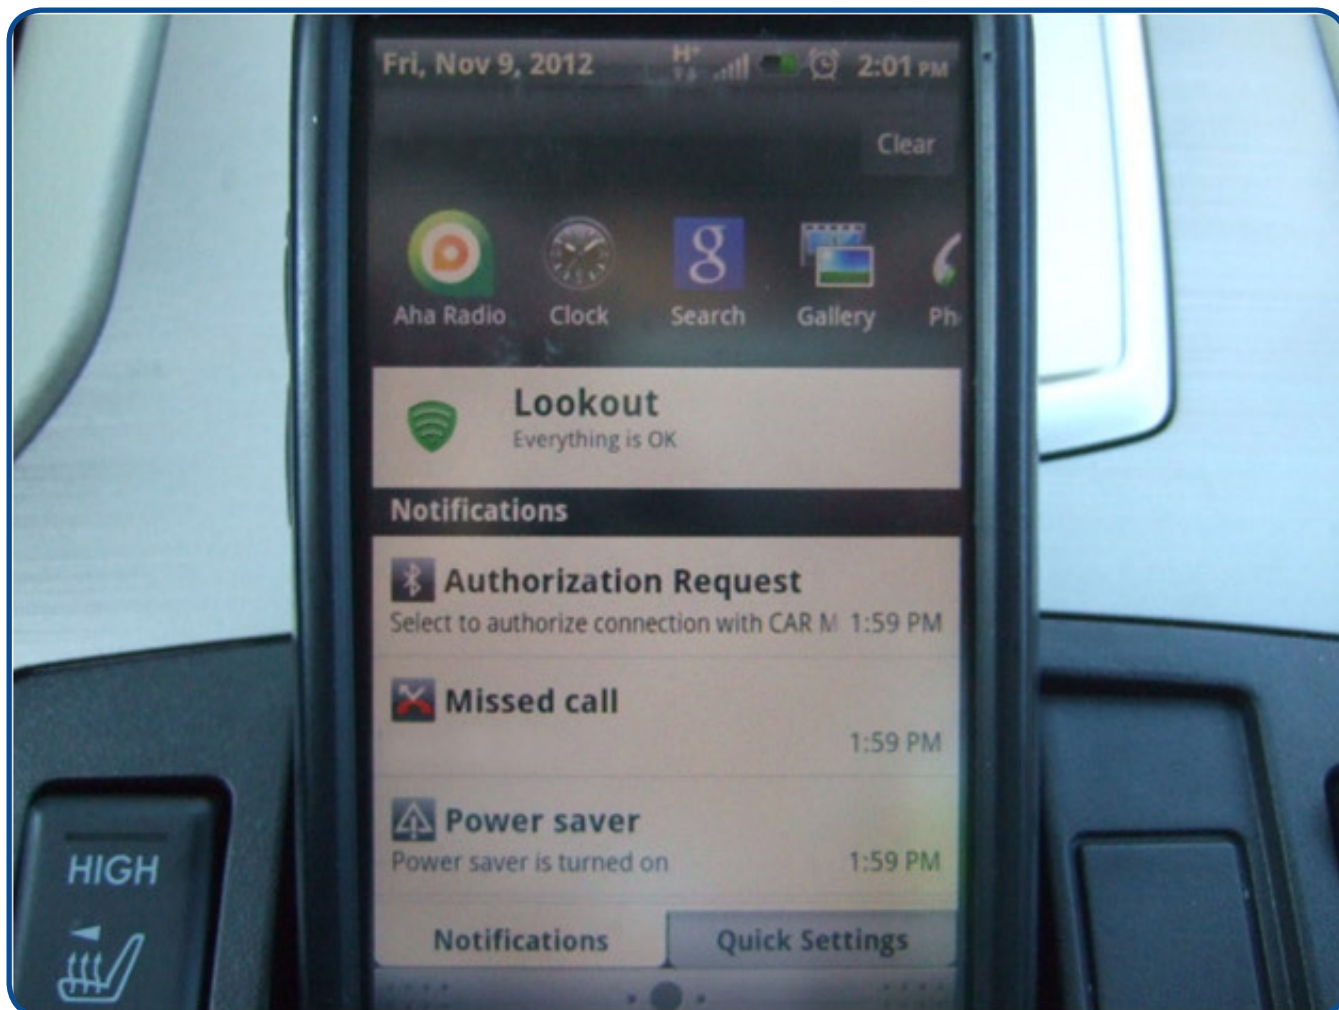
Should you encounter a customer concern of trouble pairing their phone to either a new or exchange audio unit, make sure the phone has been “authorized to pair” with an audio system as shown below. Often times, a customer may miss a screen showing this message “Authorization Request”. This screen disappears very quickly and should be checked if you encounter pairing issues. The photo below of this screen shows an Android phone.

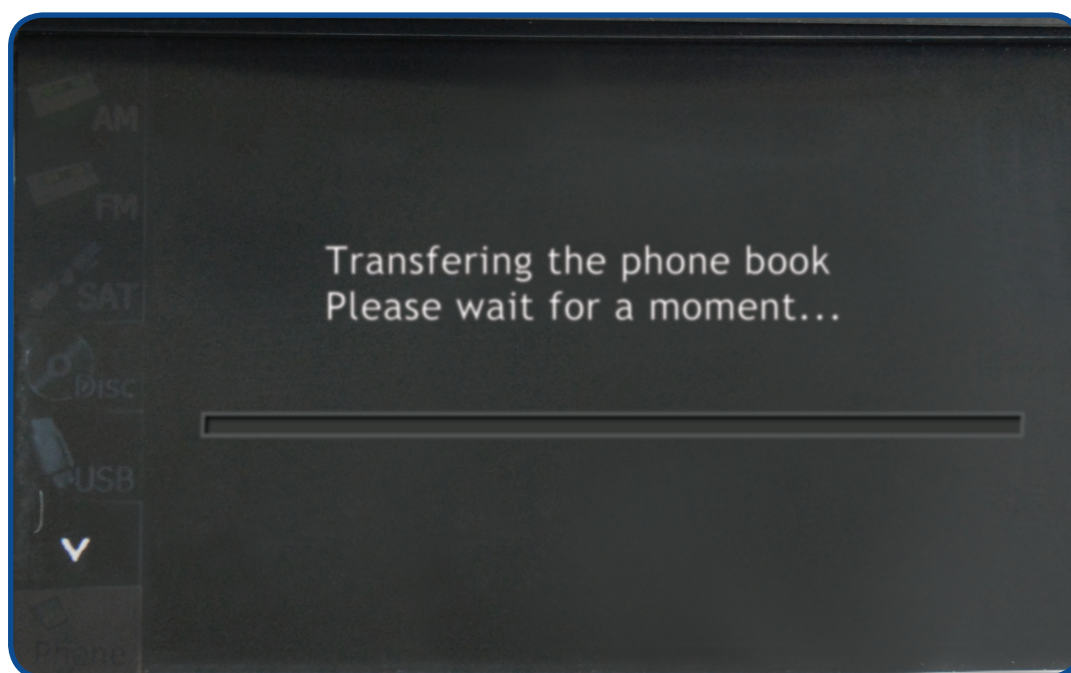
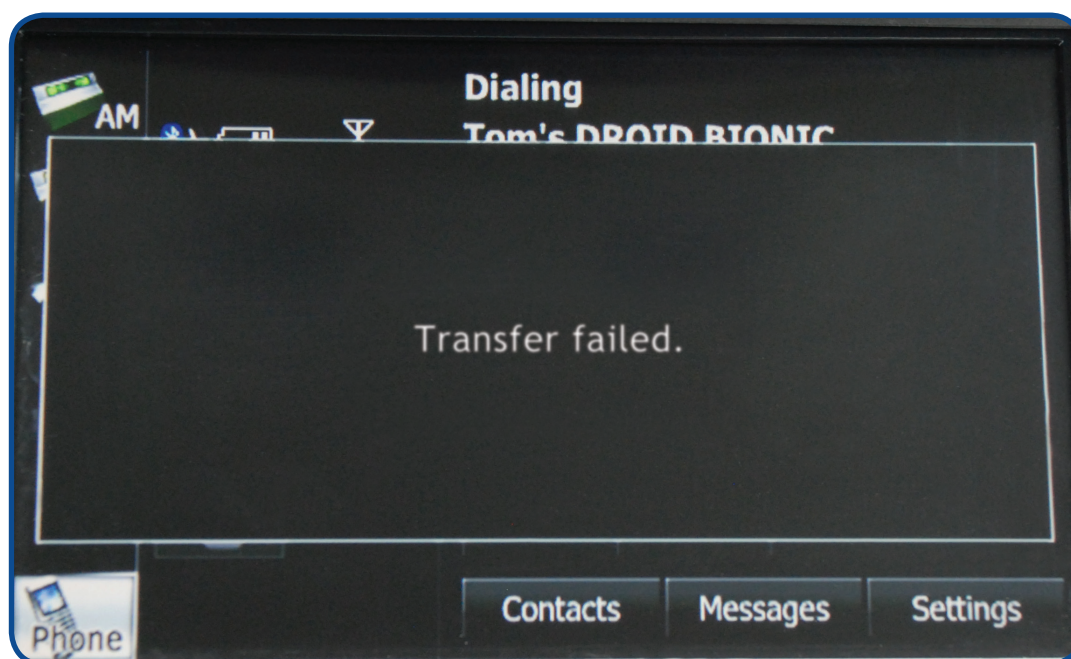
complete or time out and a “Transfer failed” message appears before attempting to activate other system features. The other common cause of an extended “Transferring the phone book. Please wait a moment” message is similar to the above information where the customer’s phone is waiting for permission to be given by the user to allow the transfer of this information. Again, this message may appear very quickly on the phone screen and the user may miss it if they are not expecting it. By giving the phone permission to transfer the requested information, the amount of time to transfer the phone book should be reduced. Please see the screen shots below for what these messages look like on the audio unit display.
