Subject: CRUISE MAIN INDICATOR LIGHT (AMBER) OCCASSIONALLY COMES ON	Bulletin No: 09-039/12
	Last Issued: 10/18/2012

2010-2011 Mazda3

2010-2012 CX-7

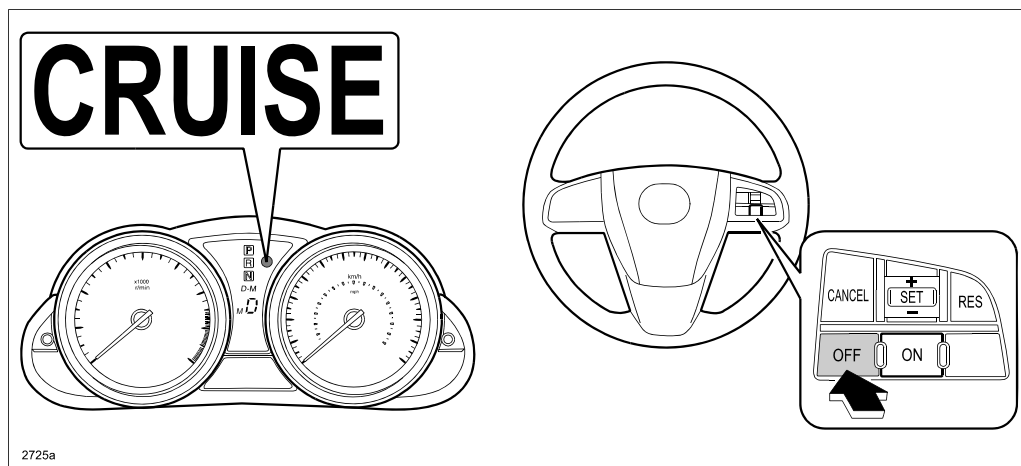
Some vehicles may experience an occasional and unexpected illumination of the cruise main indicator light (amber) with the ignition key operation cycle of OFF-START-ON. It can be cancelled by the operation of either auto cruise switch or the ignition key operation cycle of OFF-START-ON.

This problem may be caused by a weak battery (low voltage) and replacement of the battery is recommended to correct it. Use the GR8-1291 to test the battery.
