Subject: RATTLE NOISE FROM REAR STABILIZER	Bulletin No: 02-005/12
	Last Issued: 10/18/2012

2010-2012 Mazda3 vehicles (except Mazdaspeed3) with VINs lower than JM1 BL ***** 622215 (produced before March 01, 2012)

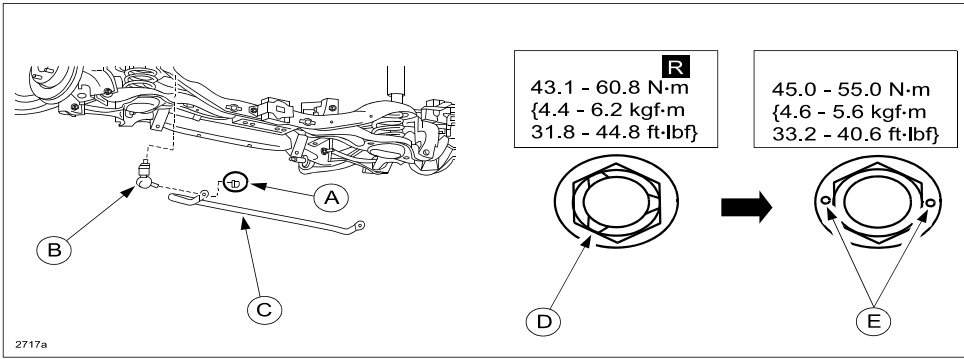
Old Style Locking Nut	New Style Locking Nut

Some vehicles may exhibit a rattle type noise coming from the rear stabilizer when driving over a road bump. This noise may be caused by a loose rear stabilizer control link.

<div> <div> R 43.1 - 60.8 N·m {4.4 - 6.2 kgf·m 31.8 - 44.8 ft·lbf} </div> <div>

</div> </div>	<div> <div> 45.0 - 55.0 N·m {4.6 - 5.6 kgf·m 33.2 - 40.6 ft·lbf} </div> <div>

</div> </div>
Item	Description		
A	Locking Nut		
B	Rear Stabilizer Control Link		
C	Rear Stabilizer		
D	Old Style Locking Nut		
E	New Style Locking Nut With Identification Marks

1. Verify customer concern.
2. Verify the rear stabilizer control link nut torque is below the 31.8 - 44.8 ft-lbf specification.
3. If loose, replace with new nuts (A). Refer to MS3 online or Workshop Manual (section 02-14 REAR STABILIZER REMOVAL/INSTALLATION).

NOTE: After removing the nuts, inspect the threads of the bolts. If wear exists, replace the control link.
