Service Bulletin

Subject:
PANDORA FUNCTION FOR AUDIO SYSTEM IS NOT AVAILABLE
Last Issued: 11/28/2012

2013 Mazda3 vehicles (with Navigation) with VINs lower than JM1BL*****743201 (produced before October 22, 2012)

Bulletin No: 09-045/12	Last Issued: 11/28/2012
© 2012 Mazda Motor of America, Inc.

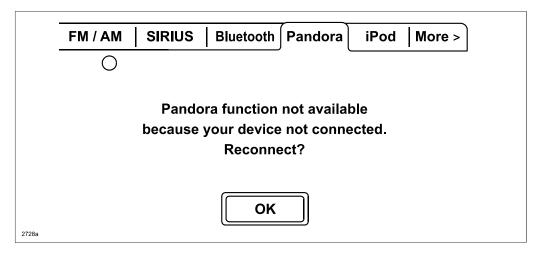
Some vehicles may experience that Pandora gets disconnected with a message as shown. This happens when Pandora is playing via Bluetooth and an iPhone/iPod, etc. is connected or disconnected from the USB terminal. To get Pandora to play again, the Pandora application needs to be restarted. This is caused by improper software of the Bluetooth unit. To correct the problem, the software of the Bluetooth unit has been changed.

Customers having this concern should have their vehicle repaired using the following repair procedure.
