UNUSUAL RATTLE / BUZZ TYPE NOISE FROM PRESILENCER

Bulletin No: 01-026/12

Last Issued: 11/20/2012

2010-2013 CX-9 vehicles with VINs from JM3 TB ***** 200001 to JM3 TB ***** 400869 (produced from July 28, 2009 to October 15, 2012)

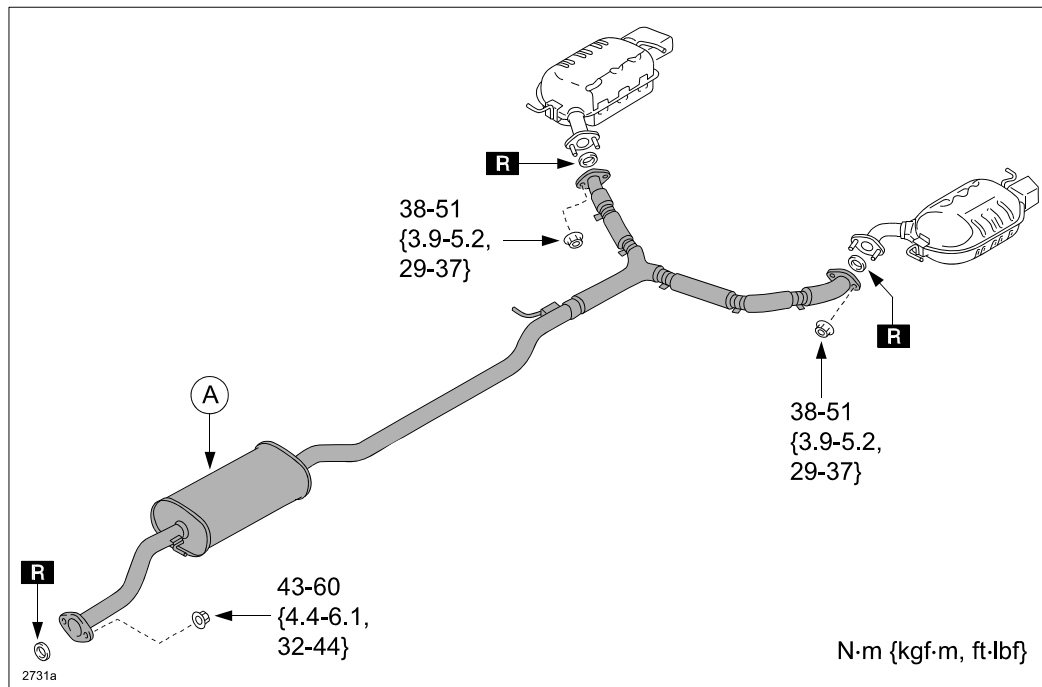
Some vehicles may exhibit an unusual rattle/buzzing type noise from the presilencer when driving at approximately 1800 rpm.

1. Verify customer concern.
2. Replace the presilencer (A). Refer to MS3 online or Workshop Manual (section 01-15 EXHAUST SYSTEM REMOVAL/INSTALLATION [MZI-3.7]).
