Subject: DRIVER-SIDE MIRROR VIBRATION WHEN DRIVING ON ROUGH ROAD OR HIGHWAY	Bulletin No: 09-044/12
	Last Issued: 11/20/2012

2010-2012 CX-9

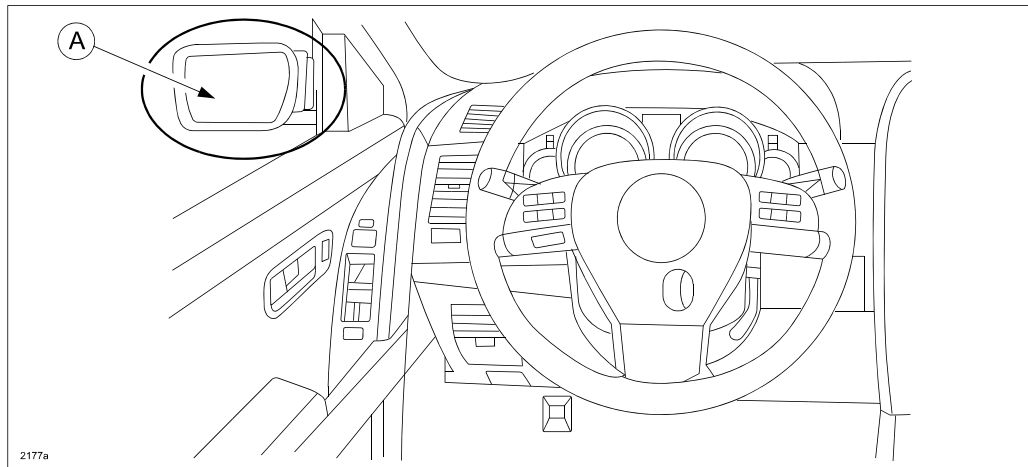
Some vehicles may exhibit a vibration on the driver-side rear view mirror (A) when driving on a rough road or highway. The mirror vibration may get worse when vehicle speed is over 65mph (105Km/h). During these conditions, customers may complain that the driver-side rear view mirror is difficult to see.

The following repair procedures have been developed to reduce vibration concern.
