<b>Subject:</b>  EXHAUST LEAK NOISE FROM REAR OF VEHICLE	<b>Bulletin No:</b> 01-025/12
	<b>Last Issued:</b> 11/16/2012

2009-2012 Mazda6 vehicles produced before June 7, 2012

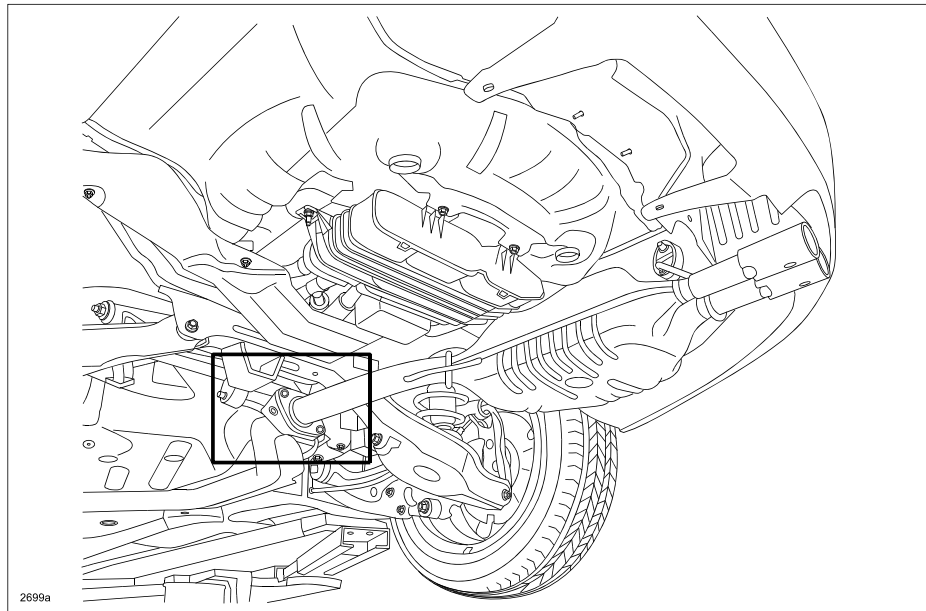
### 2.5L Engine:

1. Verify customer concern.
2. Safely raise vehicle on hoist.
3. Locate the exhaust joint between the main silencer and pre-silencer as shown below.

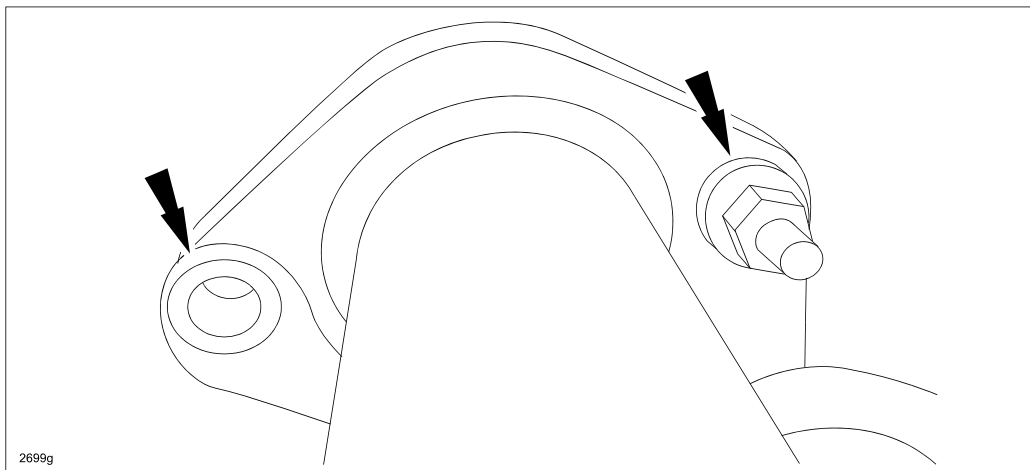
**4. Inspect for broken or missing exhaust studs:**

- If either stud is broken or missing, proceed to the next step.
- If neither stud is broken or missing, refer to the instructions on MS3 online or the Workshop Manual for further troubleshooting information.
