Subject: UNABLE TO LOWER REAR SEATBACK WITH REMOTE HANDLE / SEATS HARD TO LOCK	Bulletin No: 09-042/12
	Last Issued: 11/07/2012

2013 CX-5 vehicles equipped with a 4:2:4 split type rear seat with VINs lower than JM3KE*****102961 (produced before Jan. 20, 2012)

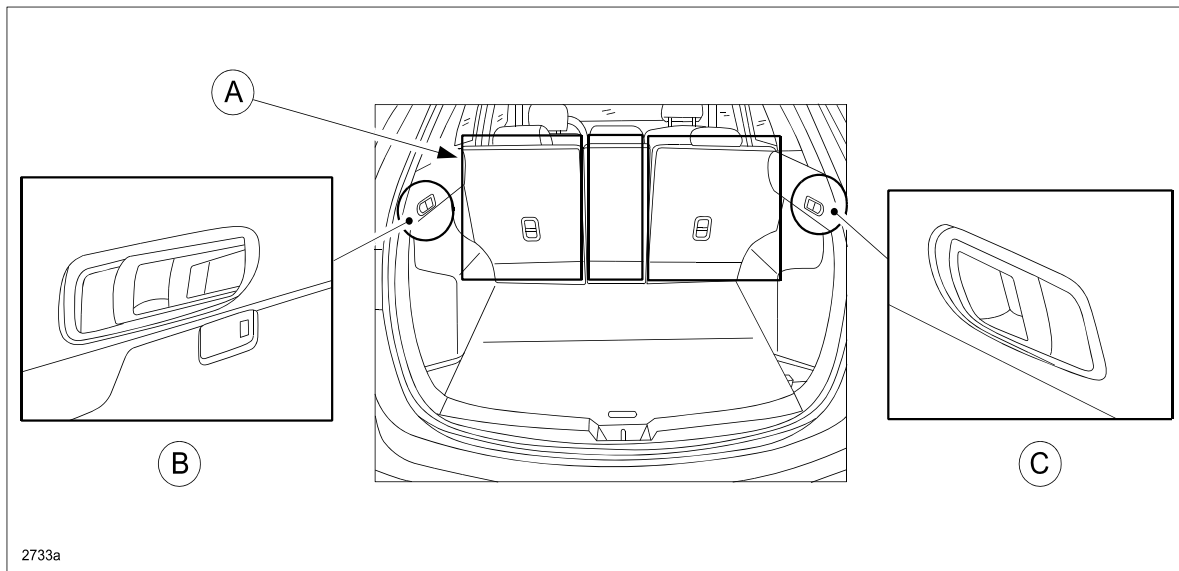
Some vehicles equipped with a 4:2:4 split type rear seat may be unable to lower the rear seatback (A) when pulling the left (B) and/or right (C) remote handles. Also, the seatbacks may not fully latch (lock) when placed in the upright position.

This concern may be caused by an incorrect seatback remote cable adjustment position. The current adjustment position may not provide enough tension for the cable to unlock the seatback latches.

The position of the seatback remote cable adjustment has been changed to the center position at mass-production.
