Subject: SHIFT SHOCK	Bulletin No: 05-004/12
	Last Issued: 11/01/2012

2012-2013 Mazda3 (SKYACTIV-G and A/T) with VINs lower than JM1BL*****702072 (produced before July 25, 2012)

2013 CX-5 (A/T) with VINs lower than JM3KE*****139311 (produced before July 25, 2012)

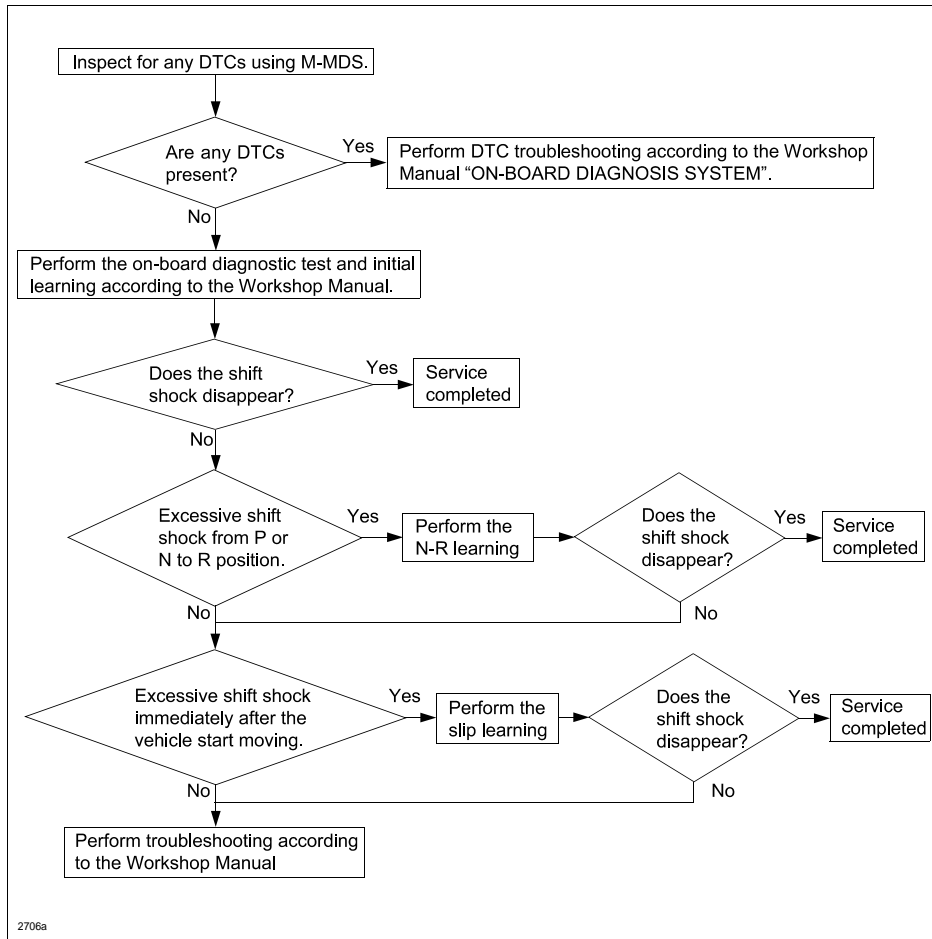
Some vehicles may experience an excessive shift shock at one or more of the following conditions:

- When shifting from P to R position or N to R position.
- When the transmission shifts immediately after starting to move (in D position).
- When the transmission shifts at cruising speed (in D position).

The initial learning may not have been completed at the time of vehicle production. To correct the problem, one or more learning procedures may need to be performed.

1. Verify customer concern.
2. Follow the Diagnosis Flowchart on the following page and perform the N-R and/or Slip Learning Procedure.
3. Verify repair.

1. Verify the ATF temperature reached 60°C (140°F) or over.
2. Shift the selector lever from N to R position and wait for 5 seconds
3. Shift the selector lever from R to N position and wait for 5 seconds
4. Repeat steps 2 to 3 ten times.

1. Verify the ATF temperature reached 20°C (68°F) or over (*1).
2. Drive the vehicle until upshifting from 1st to 2nd gear occurs at each of the following accelerator pedal position (APP) percentages: 20%, 40%, 60%. Monitor the APP PID using M-MDS and come to a complete stop before moving to the next one.
