Subject: NOISE FROM MAP LIGHT WHILE DRIVING	Bulletin No: 09-034/12
	Last Issued: 12/19/2012

2010 -2013 Mazda3 vehicles (including Mazdaspeed3) with VINs lower than JM1BL*****707083 (produced before August 8, 2012).

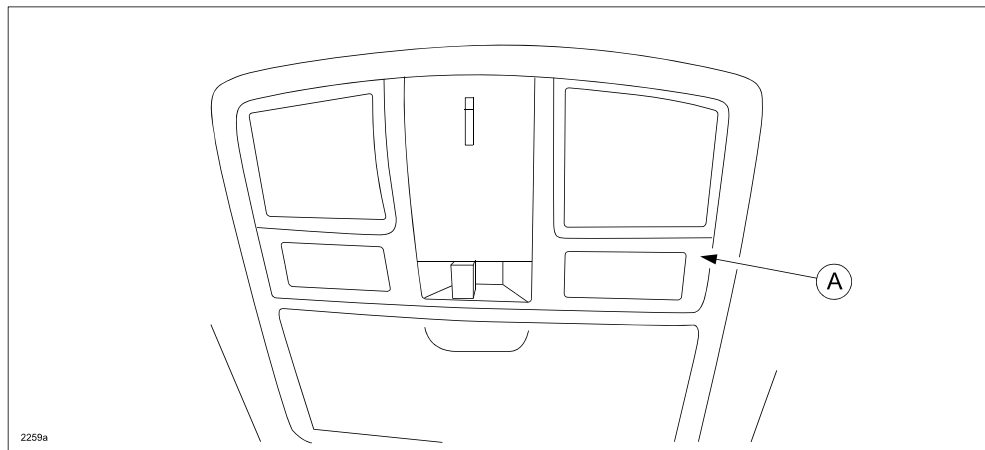
Some vehicles may exhibit a noise from the map light (A) while driving or at idle. This is caused by one of two things.

1. Excessive clearance between the map light and lamp unit positioning rib (for Mazda3 vehicles with VINs lower than JM1BL*****144839 / produced before April 1, 2009). The design of this rib has now been changed to correct this problem.
2. The overhead console bracket vibrates and contacts the roof panel (for Mazda3 vehicles with VINs JM1BL*****144839 to JM1BL*****707082 / produced after April 1, 2009 and before August 8, 2012). The noise occurs on vehicles that have a non-woven textile attached at the front stay. The material of the pads has now been changed to correct this problem.
