Service Bulletin

Bulletin No.: 02-08-42-001E

Subject: Headlamp, Tail Lamp or Fog/Driving Lamp Damage

Models: 2012 and Prior GM Passenger Cars and Trucks (Including Saturn)

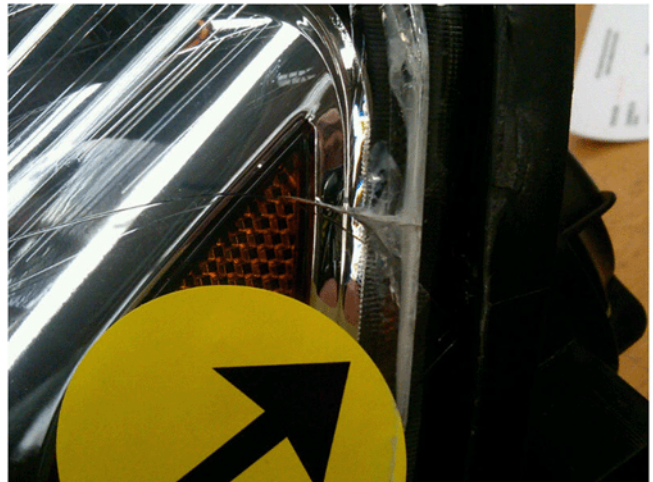
2650225

This lamp shows some effects of chemical damage. Notice the milky color along the edge and the fracture. This was caused by a solvent used to prep the body for pin stripping.

Warning: Use only lukewarm or cold water, a soft cloth and a car washing soap to clean exterior lamps and lenses.

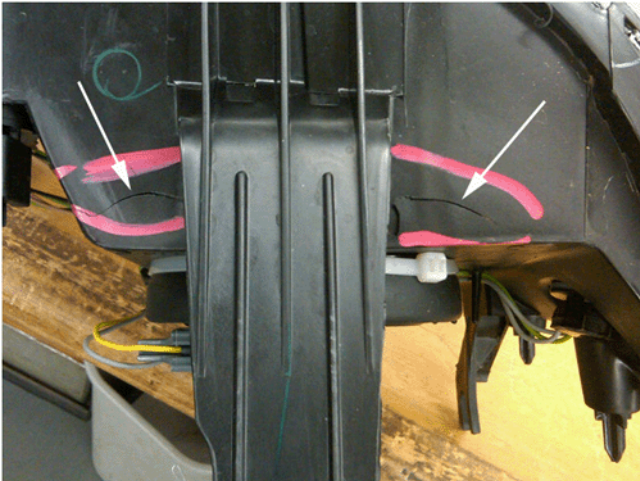
2650230

This housing is cracked across the top of the housing just below the mounting tab. Not shown is the dent at the upper edge of the lens where it impacted an object.

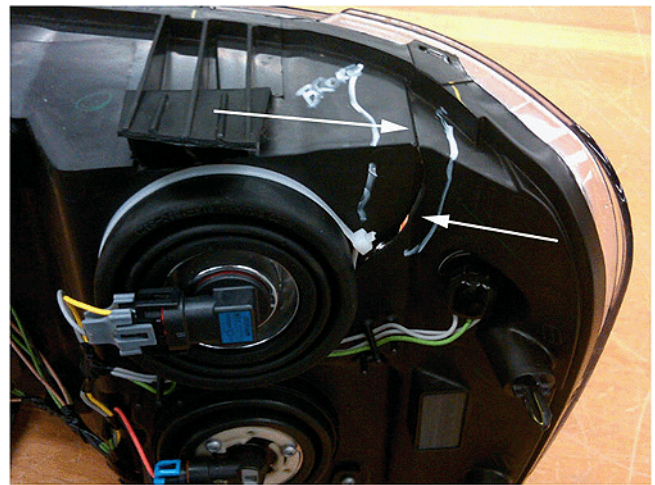
2650242

This housing shows a broken upper mounting tab and a fracture in the rear housing. This lamp had no visible marks on the lens.

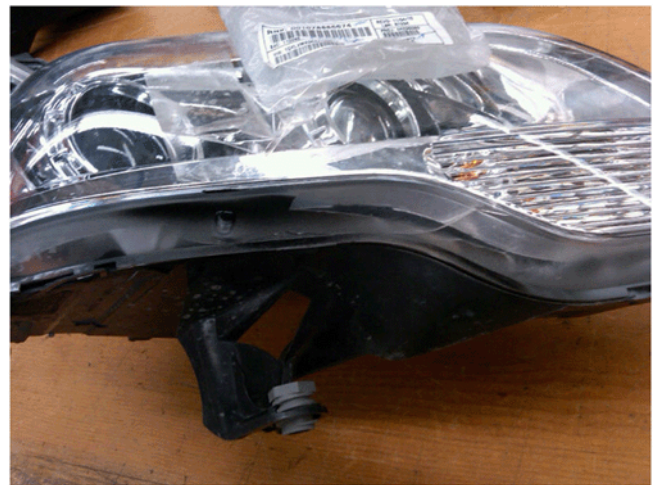
2650250

This lamp shows paint over spray along the lower edge where it would marry to the front fascia. The lower mounting tabs were also all fractured at the housing due to impact.

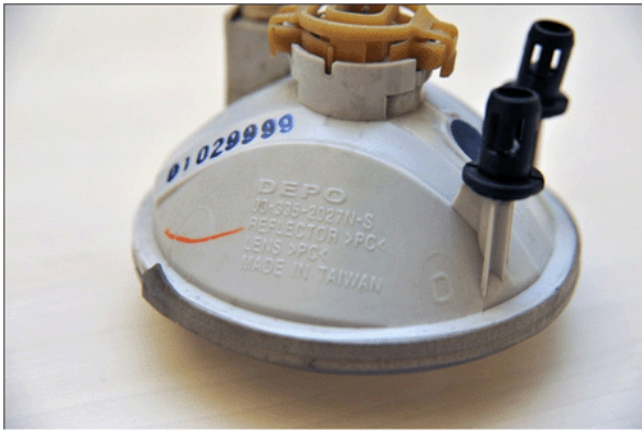
2650251

This fog lamp was returned for retaining moisture. As you can see it is marked with the Depo brand (it is also called out on the front lens).

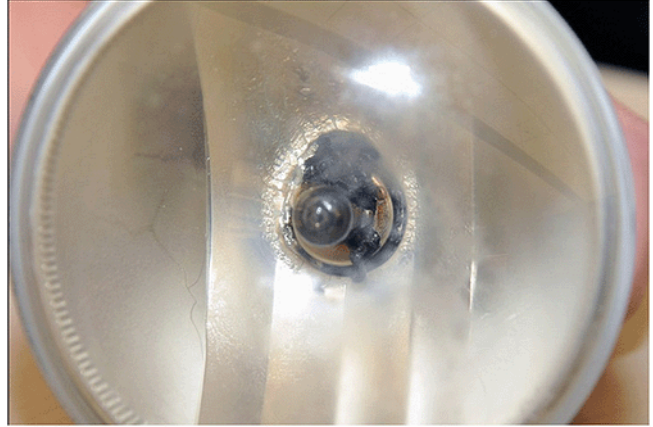
2650252

Another trend being seen is the installation of bulbs that have a higher output than the original equipment. Because the bulb output is higher, the operating temperature is also higher. This excessive heat can melt the socket, housing, or lens.
