Service Bulletin

Bulletin No.: 02-08-42-001F

Subject: Headlamp, Tail Lamp, License Lamp or Fog/Driving Lamp Damage

Models: 2013 and Prior GM Passenger Cars and Trucks

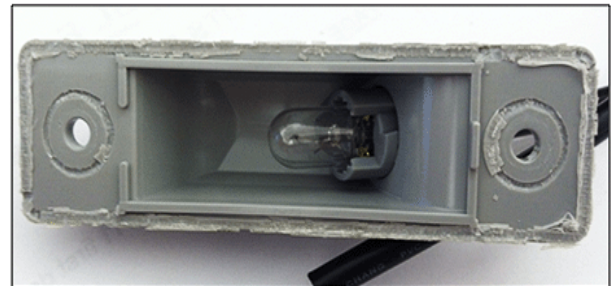
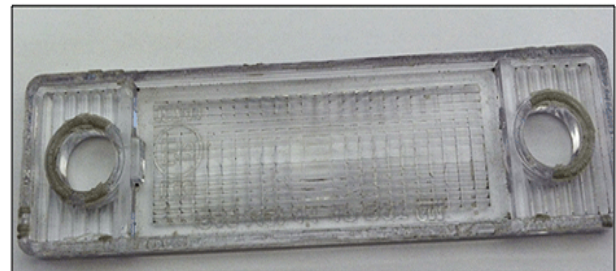
2770495

- The license lamp above exhibits a separation of the bond of the lens and housing, and a clouding of the polycarbonate lens. This condition was the result of applying chrome cleaner to the rear bumper and license lamp.

Warning: Use only lukewarm or cold water, a soft cloth and a car washing soap to clean exterior lamps and lenses.

Notice: License lamps and headlamps damaged by chemicals, improper cleaning, or overheating due to being covered are not covered under the new vehicle warranty.

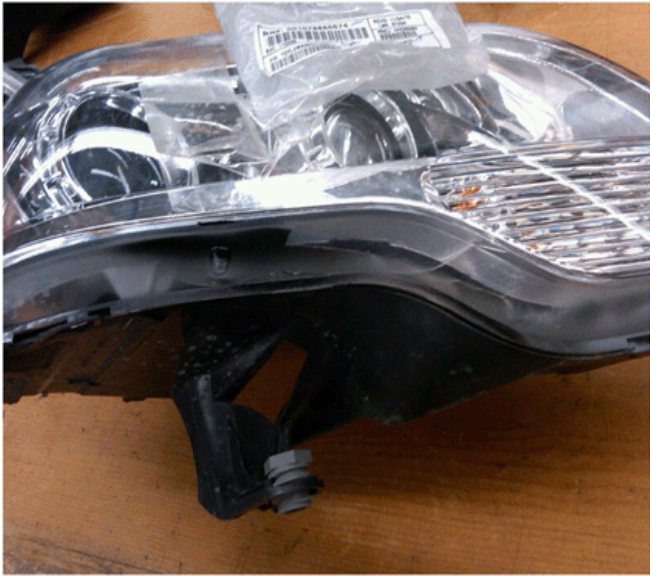
2650250

This lamp shows paint over spray along the lower edge where it would marry to the front fascia. The lower mounting tabs were also all fractured at the housing due to impact.

Notice: Headlamps damaged due to impact are not covered under the new vehicle warranty.

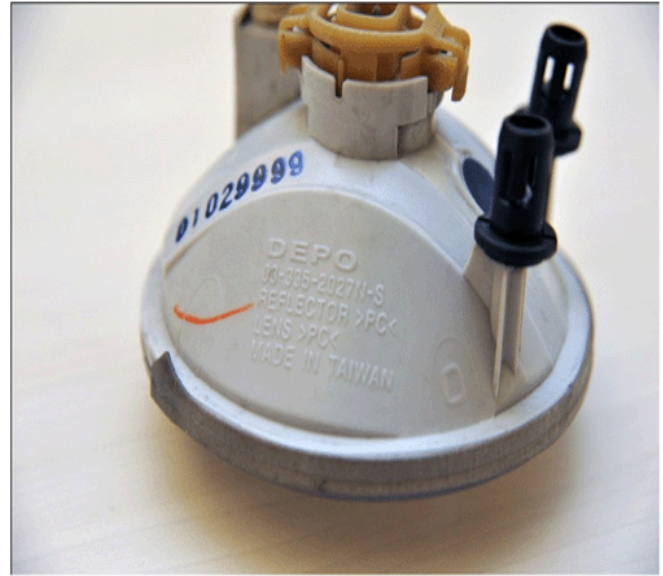
2650251

This fog lamp was returned for retaining moisture. As you can see it is marked with the Depo brand (it is also called out on the front lens).

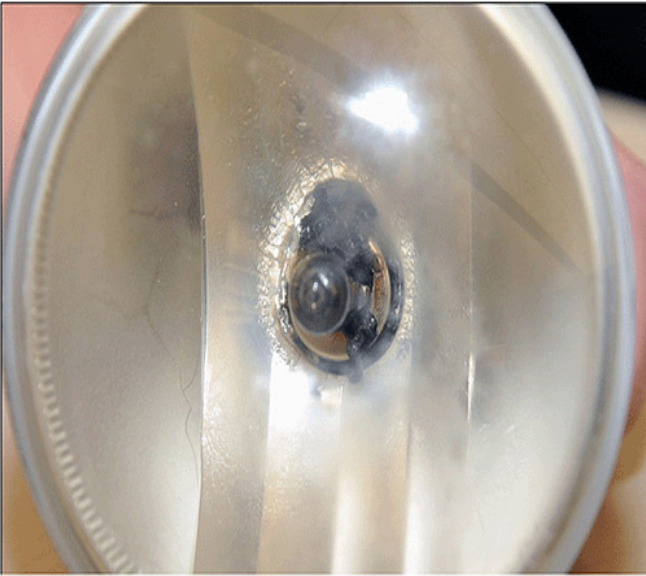
2650252

Another trend being seen is the installation of bulbs that have a higher output than the original equipment. Because the bulb output is higher, the operating temperature is also higher. This excessive heat can melt the socket, housing, or lens. Because these bulbs burn hotter and brighter, they also have a reduced service life. These bulbs are different in appearance than the original equipment. Some have blue tint on the bulb and others are clear. If in doubt, the bulb number should match the GM service part.

Notice: Headlamps or fog lamps damaged by the use of high output bulbs are not covered under the new vehicle warranty.
