# Service Action

Code: 97U3

**Subject: 2006-2007 Rabbit/R32/ GTI, 2005-2007 Jetta/Jetta Wagon,  
2007-2008 Eos and 2006-2007 Passat/Passat Wagon  
Inspect Front Seat Side Impact Airbag Connectors & Install Wiring  
Harness Kit(s), if Necessary**

**REVISED January 10, 2013**

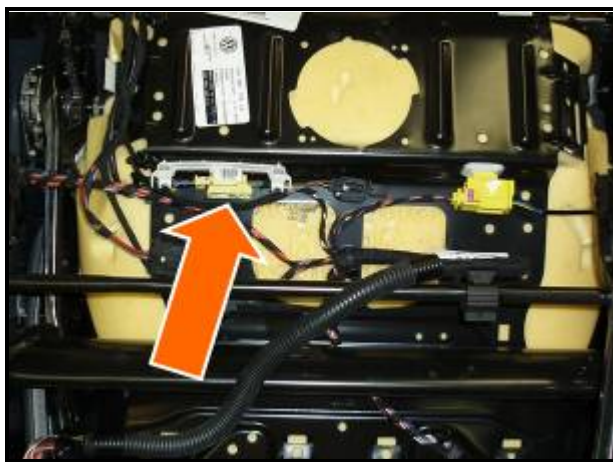
⇐ Remove male and female side connectors –arrow- (T3K –N199- driver side), (T3L –N200- passenger side, as shown) by cutting one wire at a time and as close to the connector as possible, discard connector(s)

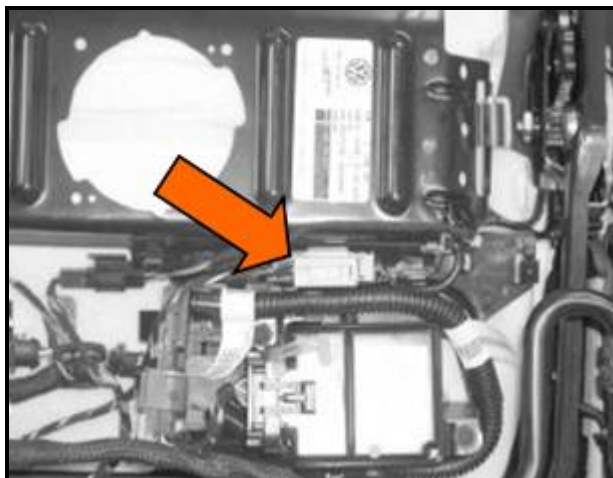
⇐ Remove male and female side connectors –arrow- (T3aa, T3ab, as shown) by cutting one wire at a time and as close to the connector as possible, discard connector(s)

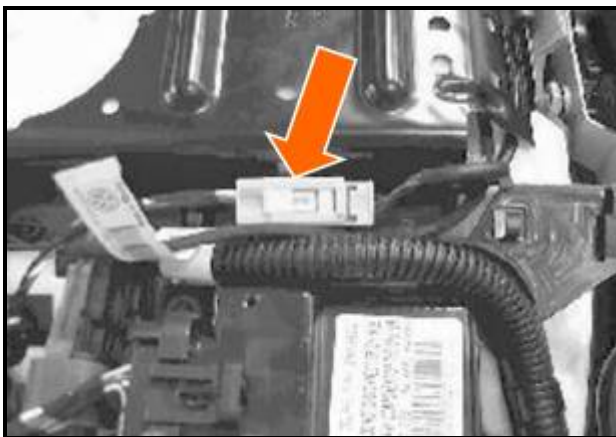
⇐ Remove male and female side connectors –arrow- (T3 –N199- driver side), (T3a –N200- passenger side, as shown) by cutting one wire at a time and as close to the connector as possible, discard connector(s)
