Program Bulletin

CUSTOMER SATISFACTION PROGRAM

SUBJECT: Pinion Nut Improperly Fastened

MODELS: 2014 Chevrolet Silverado 1500
2014 GMC Sierra 1500
Equipped with 3.73 Rear Axle Ratio (GT4) and Locking Rear Differential (G80)

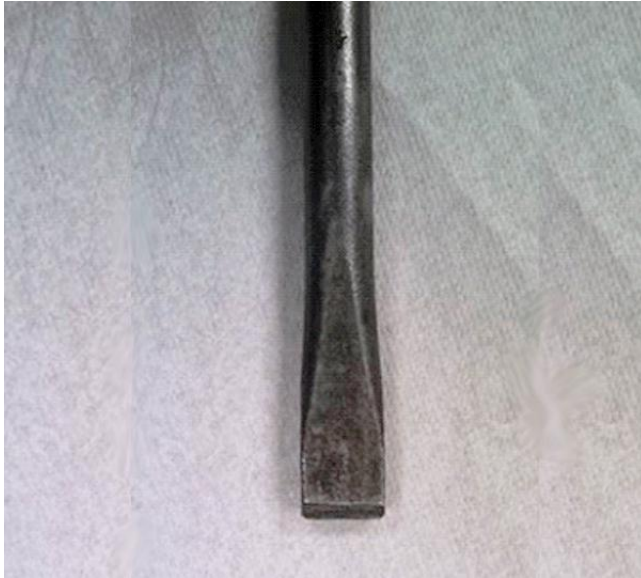
3661113

- If there is NOT access to manually stake the two sides of the drive pinion nut lip to the corresponding grooves in the drive pinion gear, reference mark the rear propeller shaft to the rear axle pinion yoke BEFORE disconnecting the propeller shaft from the axle flange. Secure the end of the propeller shaft with a strap after disconnecting the propeller shaft from the axle flange. Proceed to step 4.

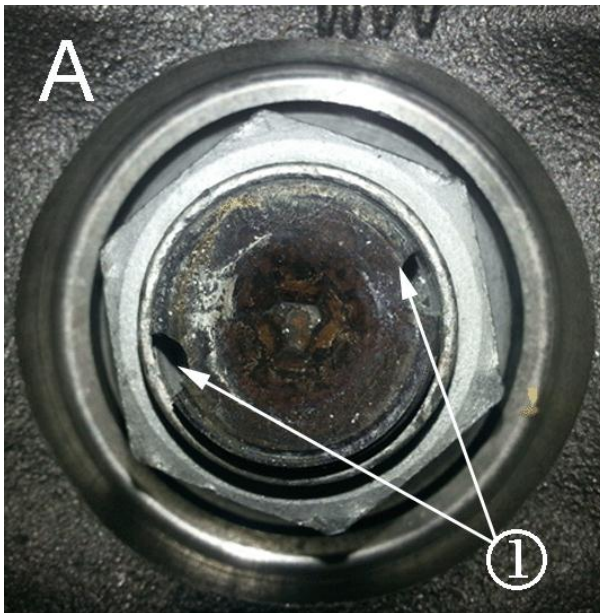
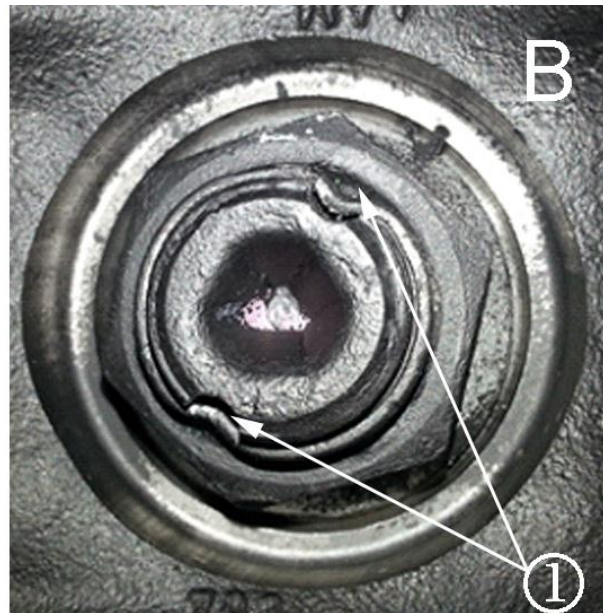
3661112

(A) No Staking (B) Acceptable Staking

Caution: Take care to not split the pinion nut lip. Splitting the pinion nut lip may affect pinion nut torque retention. Replace the pinion nut if the lip is split.

- Determine if the drive pinion nut lip (1) has been manually staked to the corresponding grooves in the drive pinion gear.
 - If the drive pinion nut lip (1) has NOT been staked, use a hammer and 5 mm (0.197 in) wide punch with a 1.8 mm (0.070 in) radius end to manually stake the two sides of the drive pinion nut lip (1) to the corresponding grooves in the drive pinion gear.
 - If the drive pinion nut lip (1) has been staked, use the punch to further stake the pinion nut into the two grooves.
