# Tech Tips

TT 61-12-01

## 2012 EOS – Convertible Top Operation Stops, Trunk Does Not Lock Properly, and/or Right Flap Does Not Close

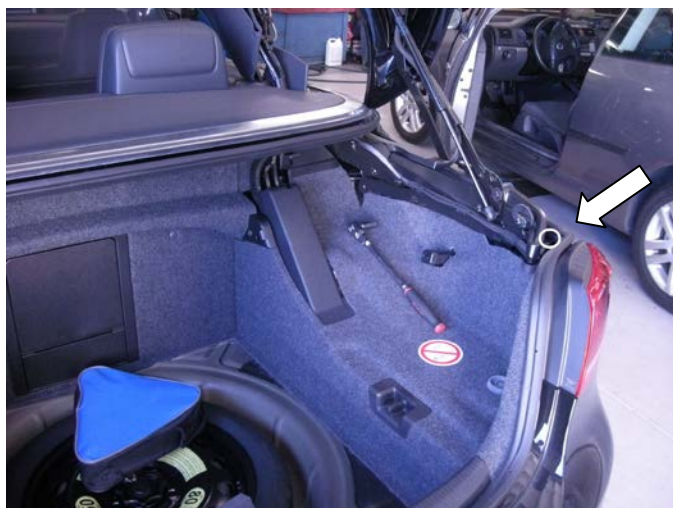
Figure 1: Overview of location on vehicle

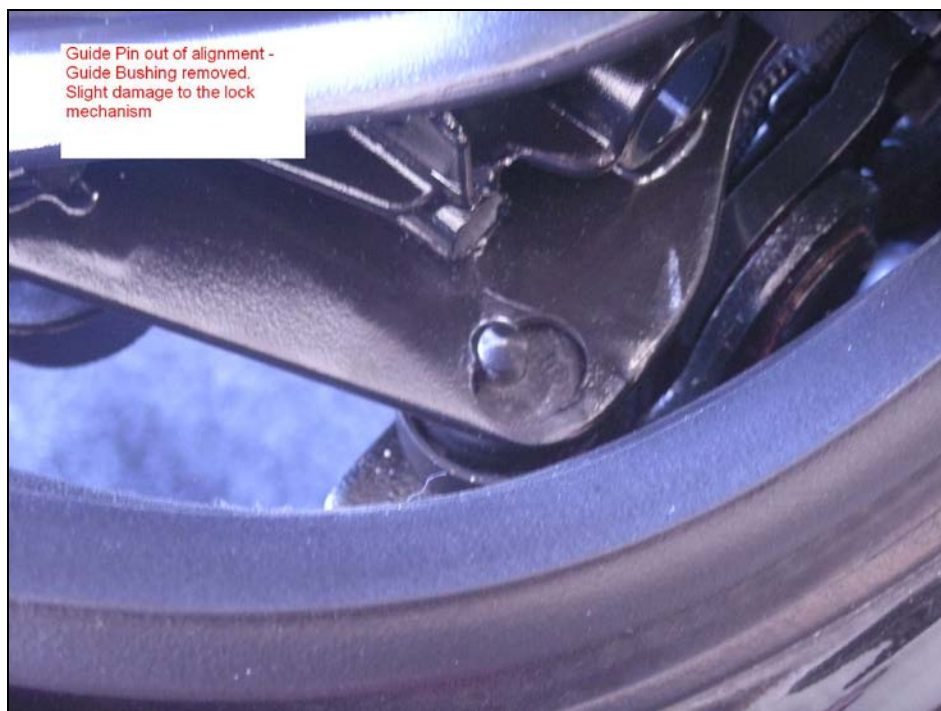
Some 2012 EOS convertible tops may not function properly during opening or closing. The trunk lock operation may not complete, which can cause trunk to be inoperative and/or parcel shelf flaps to remain open when top opening cycle has completed. This may affect the G562, G563, or G564 sensors when running the test plan or looking at MVB 2. The guide bushing at the back of the lock mechanism (location circled in figure 1 below) may not align with the guide pin mounted on the body. It is necessary to remove trim on lock mechanism to inspect guide bushing. Misalignment of lock mechanism can cause damage to the guide bushing. The lock mechanism will need to be adjusted and the guide bushing replaced in most instances.

Figure 2: Guide pin out of alignment (shown with bushing removed)

To repair, open the trunk to access the underside of the parcel shelf. Remove the guide bushing if it is damaged. Loosen the 2 lock mechanism mounting nuts shown in figure 3 below on the underside of the parcel shelf (be sure to only loosen these 2 nuts due to pretension on the lock assembly). Adjust the locking mechanism so that the rear alignment guide pin is centered in the guide bushing hole. Resecure the 2 mounting nuts to 22NM. Close the trunk and cycle the top to check functionality. If the guide bushing was found to be damaged, replace with part number 1Q0898162A (see ETKA for latest supersession).

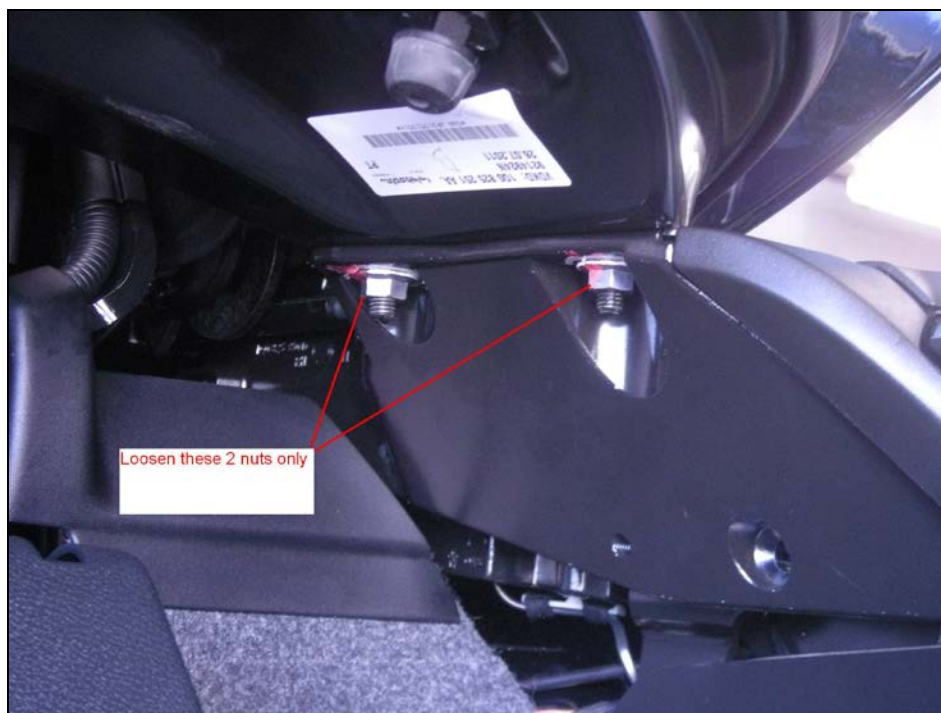
Figure 3: Lock mechanism mounting nuts

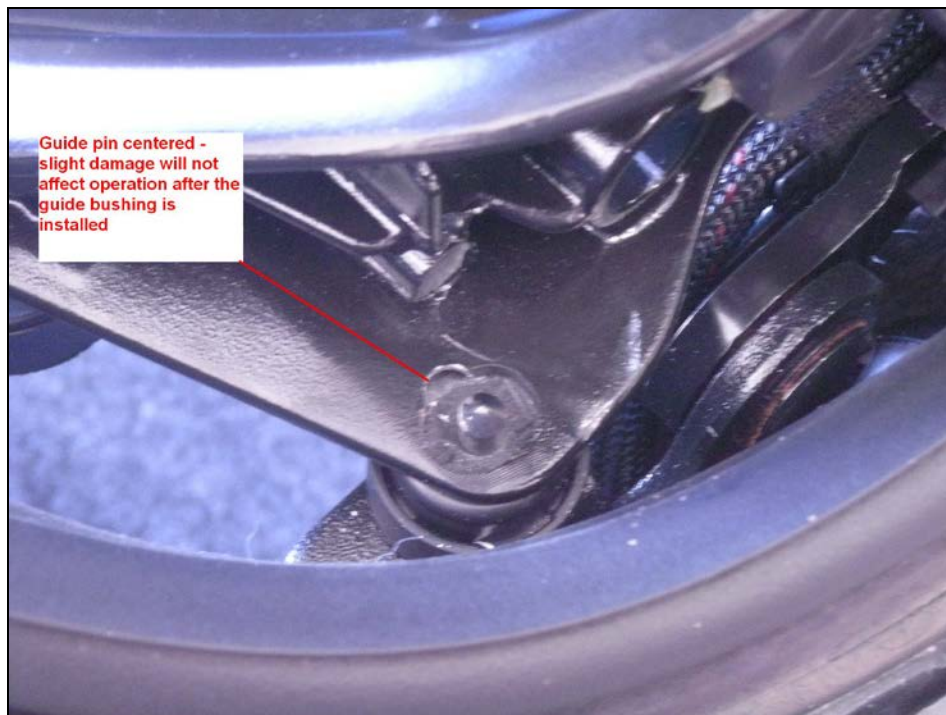
**Figure 4: Guide pin centered after adjustment and before installation of new guide bushing.**
