Reference SSM51797

Title Smart Key cover detaching from the Casing

Title Remote Key cover detaching from the Casing

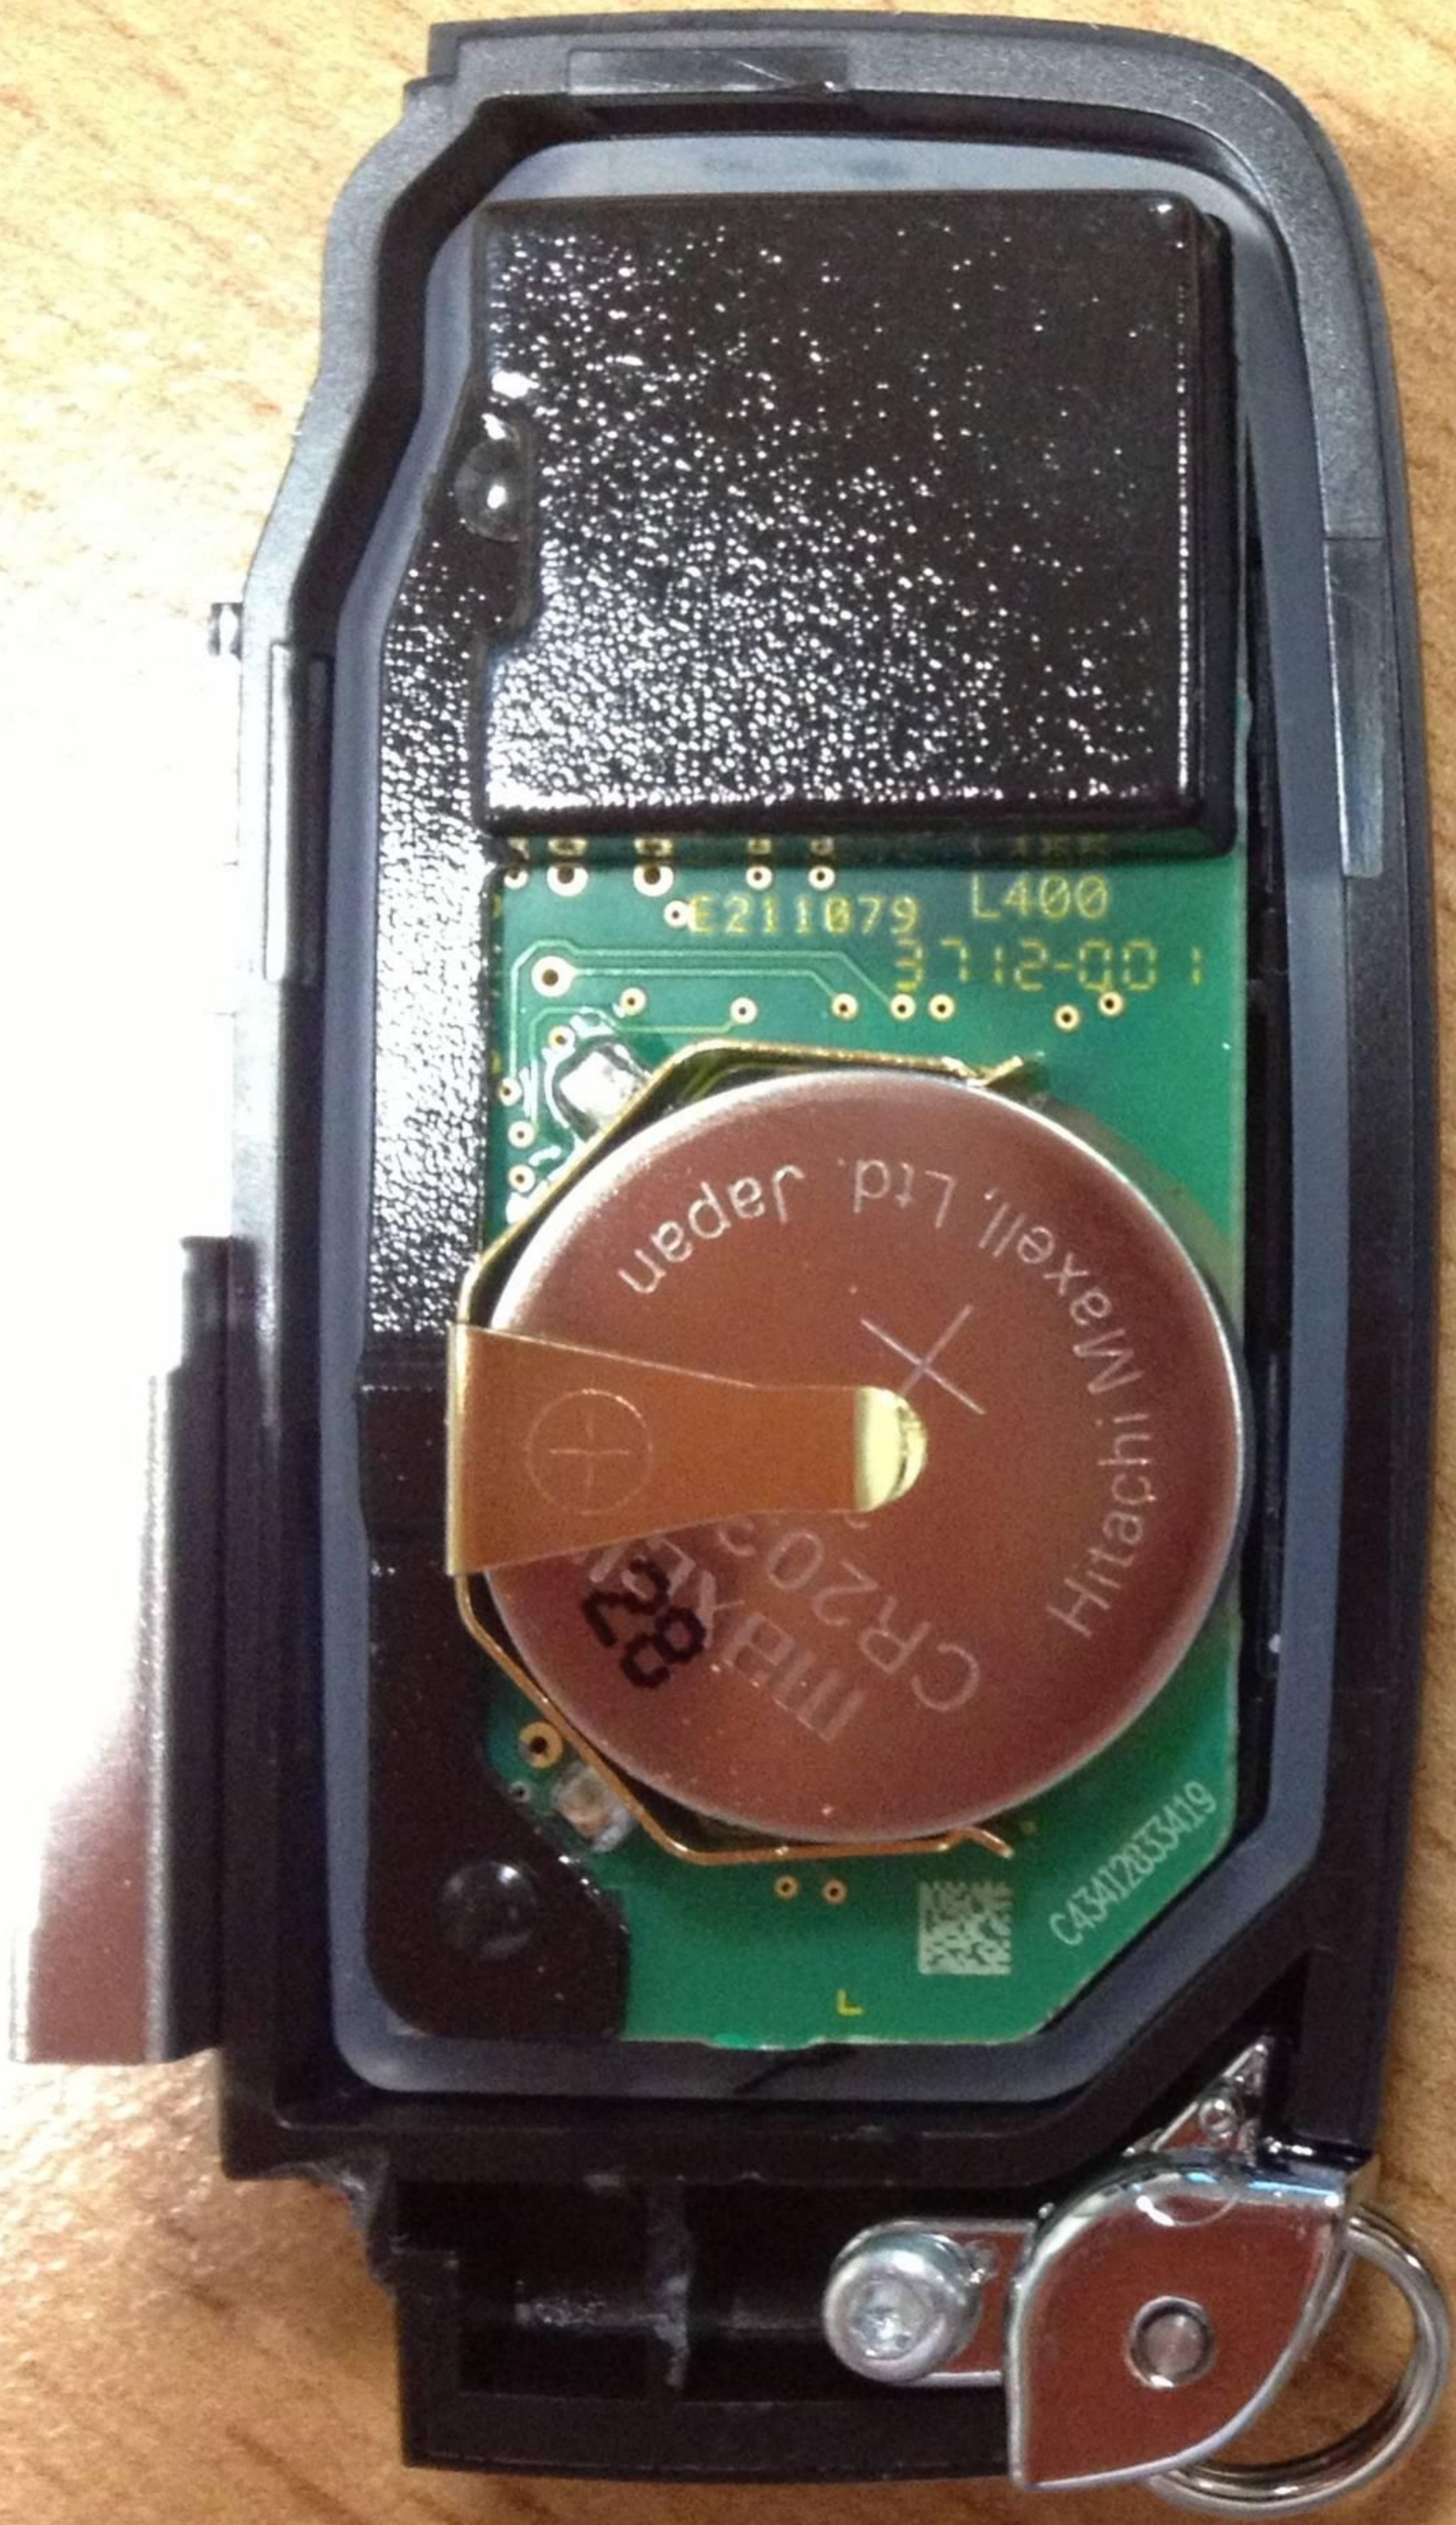
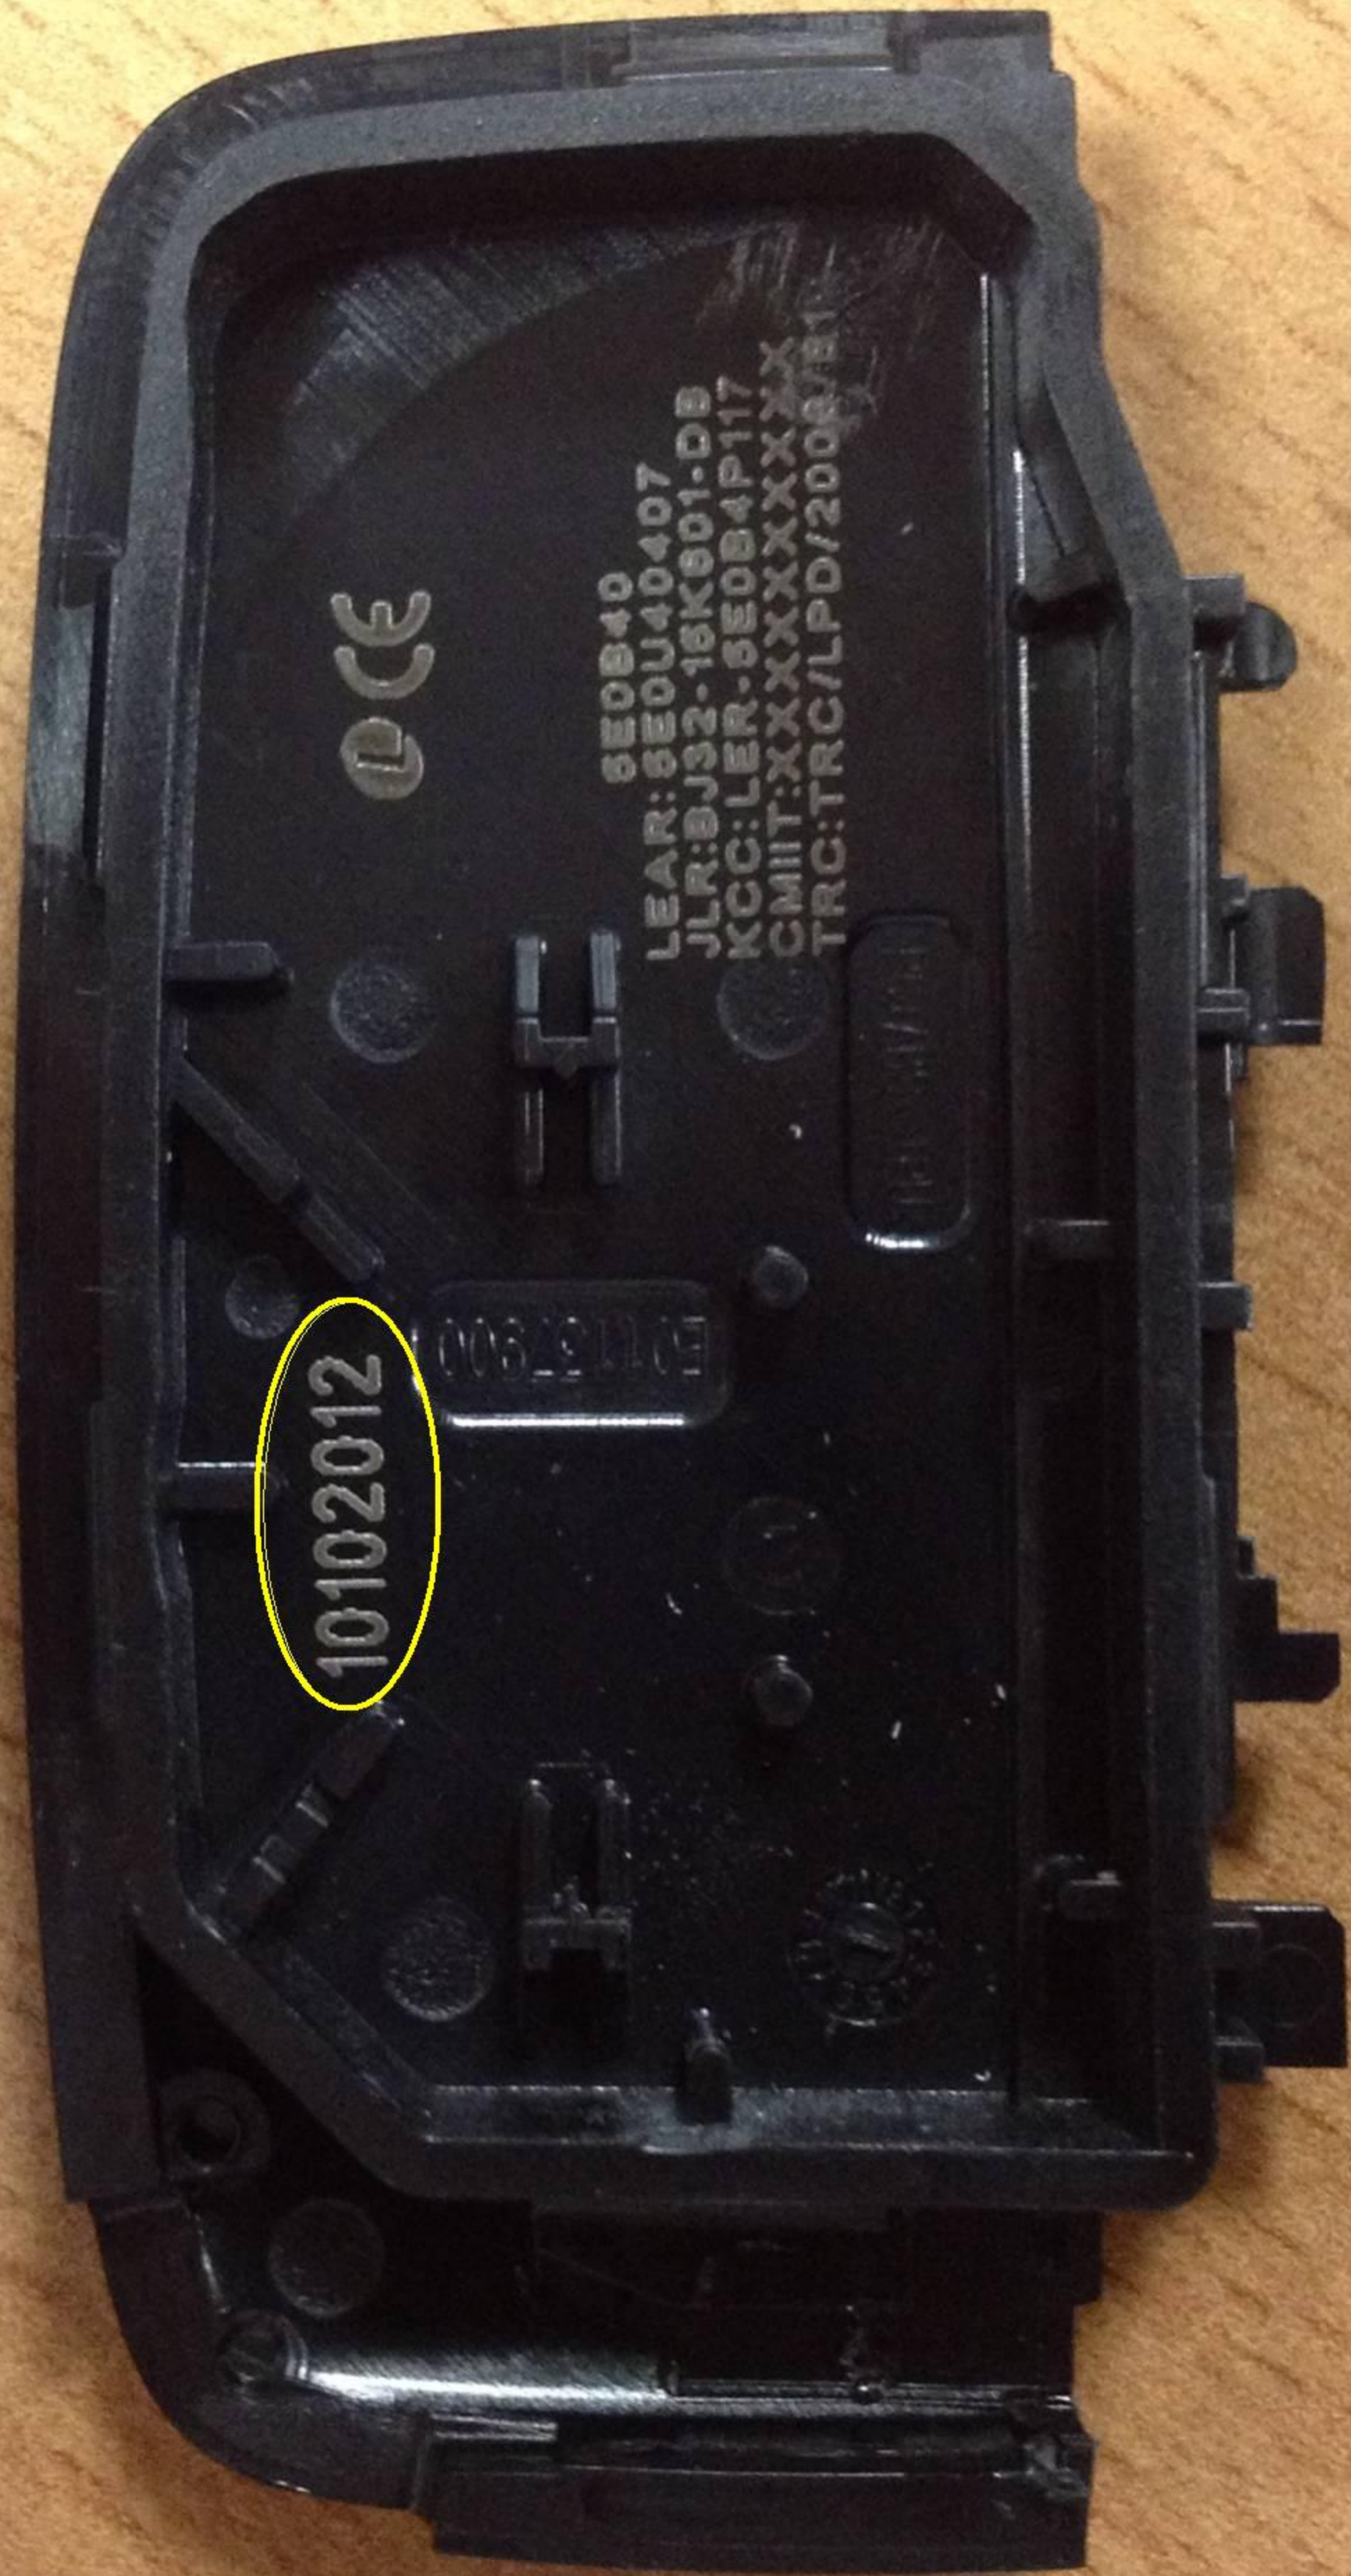
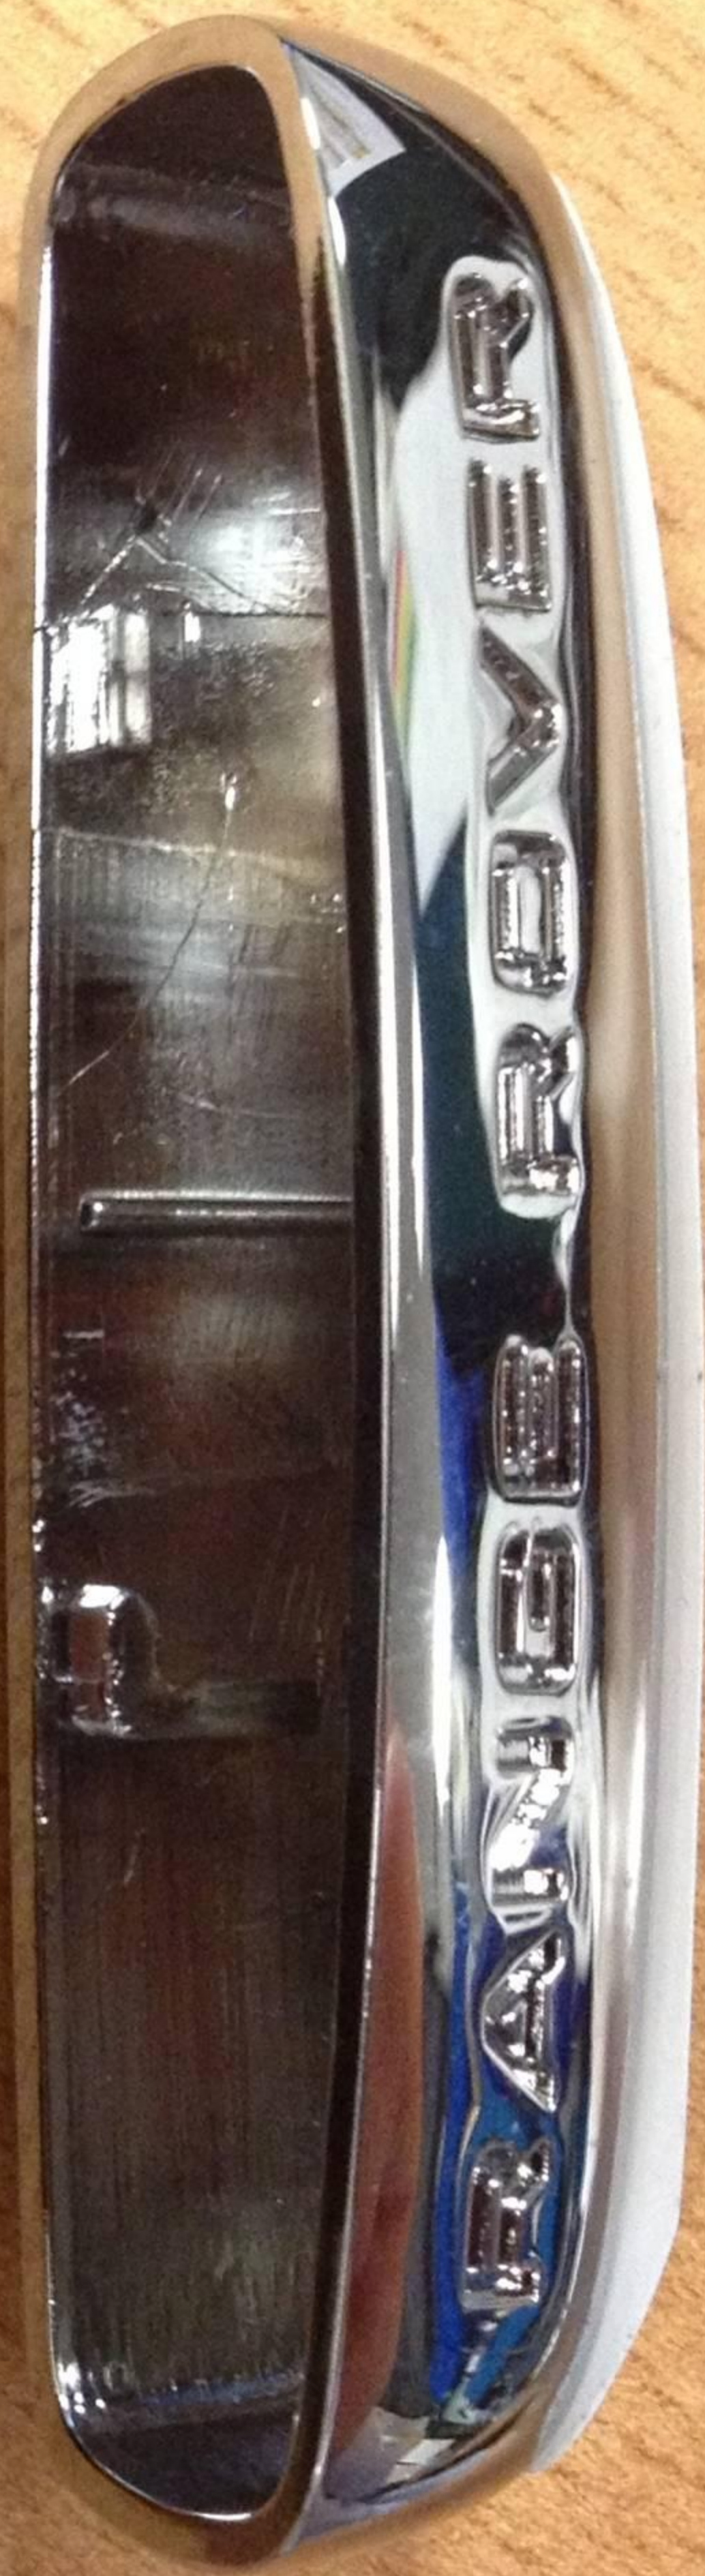
The outer Cover on the remote key can detach from the casing. See attachment.

The Root cause was found to be that anti rust oil residue remains on the supplier's tooling at the start of a production run.

The issue is resolved from 18th September 2012. The date date code format and location are different between pre and post 12my vehicles.

120918 (year 2012, month September, day 18th), see 2nd attachment for location.

18092012(day 18th, month September, year 2012) see 3rd and 4th attachment.

Please only submit EPQR's for failures after this assured date.

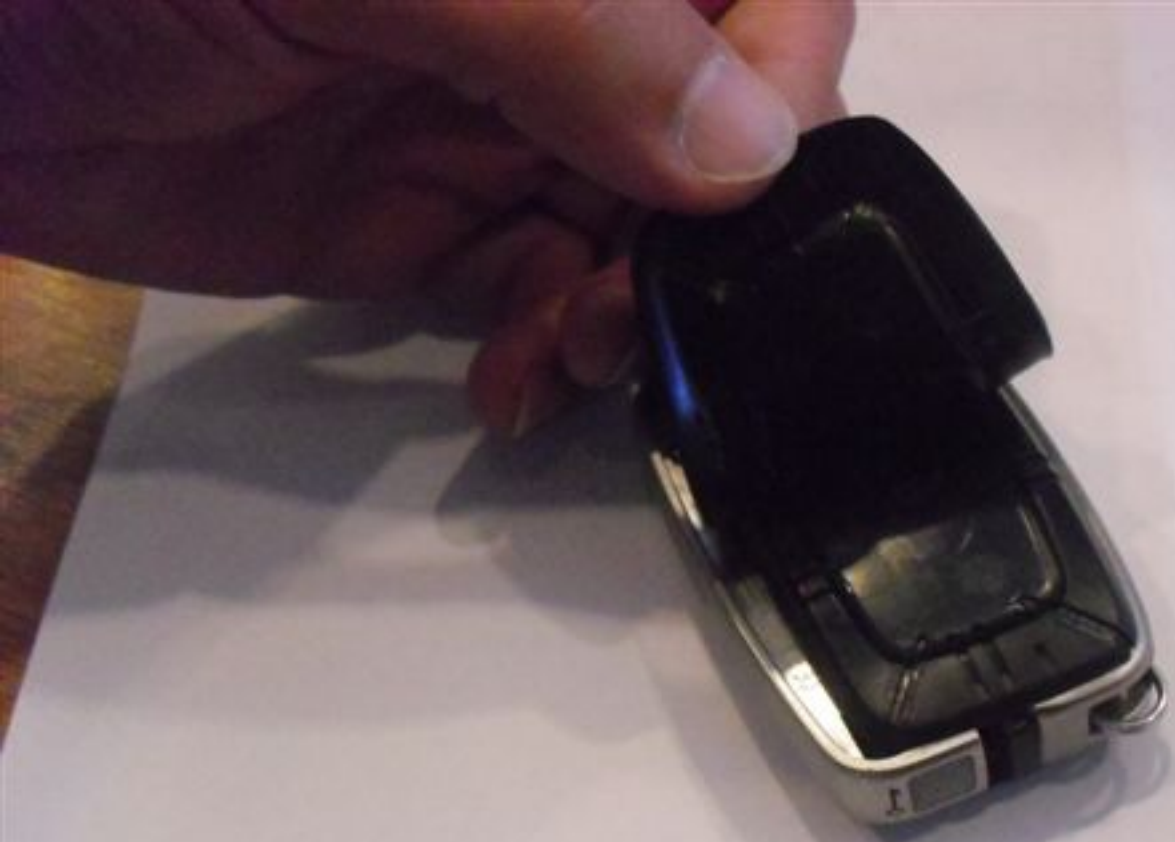
DATE CODE: 101009
LEAR P/N: 5E0B601A7
JLR P/N: AH22-15K601-BF
