Service Bulletin

Bulletin No.: PIC5718B

Subject: Instrument Panel (IP) Center Soft Insert Above Radio Center Stack Appears Deformed or Wrinkled

Models: 2012 - 2013 Chevrolet Camaro

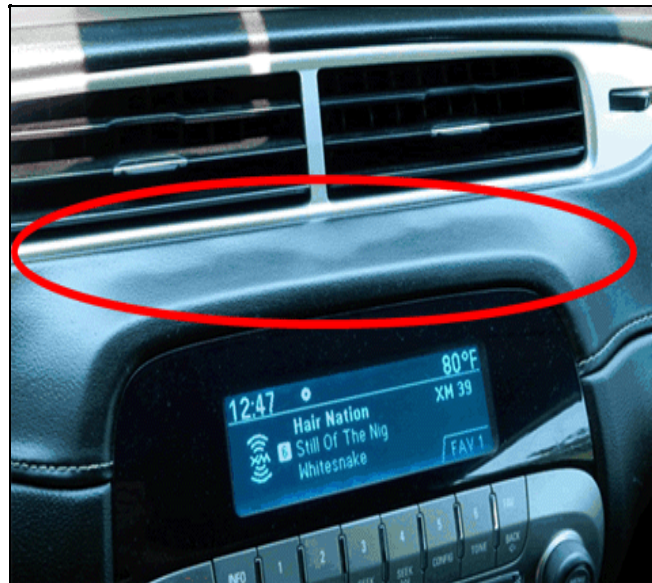
2897713

Some customers may comment that the dash pad area surrounding the radio center stack appears to be deformed or wrinkled. This area may be slightly to the left or right of the center stack, or even directly above it, as shown in the picture below. Some customers may comment that this trim piece was not like this when the car was new. Dealers may comment that the service replacement trim piece is similar in appearance when it had been removed from the packaging. They may also notice that after this trim piece has been replaced and exposed to direct sunlight for some time, the concern has reoccurred.

This parts issue has been resolved and new stock is currently available at GM CCA for this concern. Order a new dash pad as needed to resolve this issue on customer vehicles.
