Service Bulletin

Bulletin No.: PIC5718C

Subject: Instrument Panel (IP) Center Soft Insert Above Radio Center Stack Appears Deformed or Wrinkled

Models: 2012 - 2013 Chevrolet Camaro

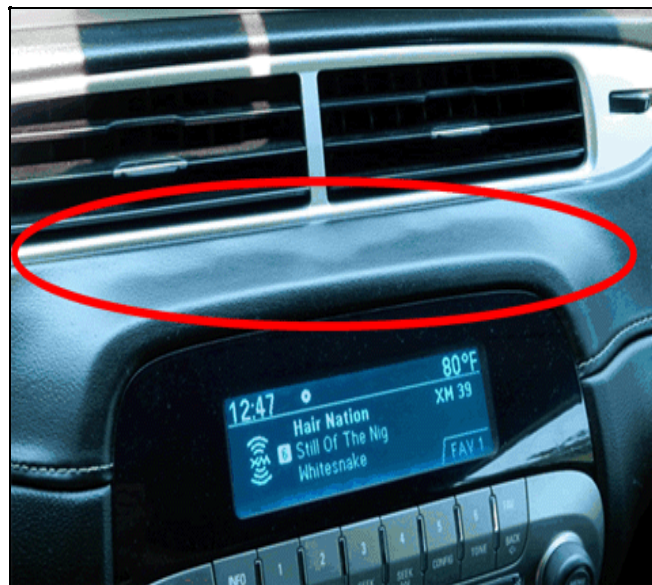
2897713

Some customers may comment that the dash pad area surrounding the radio center stack appears to be deformed or wrinkled. This area may be slightly to the left or right of the center stack, or even directly above it, as shown in the picture below. Some customers may comment that this trim piece was not like this when the car was new. Dealers may comment that the service replacement trim piece is similar in appearance when it had been removed from the packaging. They may also notice that after this trim piece has been replaced and exposed to direct sunlight for some time, the concern has reoccurred.

This parts issue has been resolved and new stock is currently available at GM CCA for this concern. Order a new dash pad as needed to resolve this issue on customer vehicles.
