# Service Bulletin

Bulletin No.: PIC5720A

**Subject:** Hum or Buzz Noise Right Front, Service Brake Assist, ABS or SES MIL

**Models:** 2012 - 2013 Buick Lacrosse  
2012 - 2013 Buick Regal  
2014 Chevrolet Impala ECO  
2013 Chevrolet Malibu ECO  
with eAssist (RPO HP6)

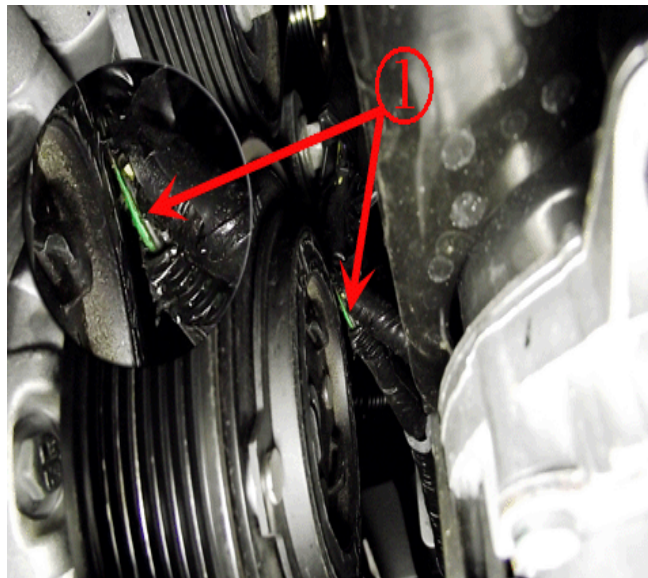
Underhood wiring harness may be contacting the crank pulley, air conditioning compressor pulley or accessory drive belt due to misrouting or not secured properly.

Repair wiring as needed or replace the harness, correct routing and properly secure. Once wiring repairs are complete, confirm proper brake booster vacuum pump operation. The pump can be commanded on using GDS2. Clear all DTCs.
