Service Bulletin

Bulletin No.: PIC5736B

Subject: Inner Door Trim Panel Squeak Noise

Models: 2013 Cadillac ATS
Built prior to D0145344

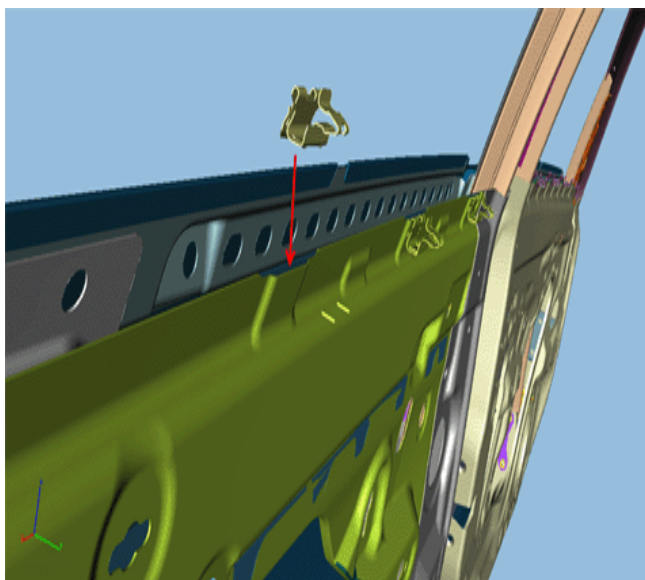
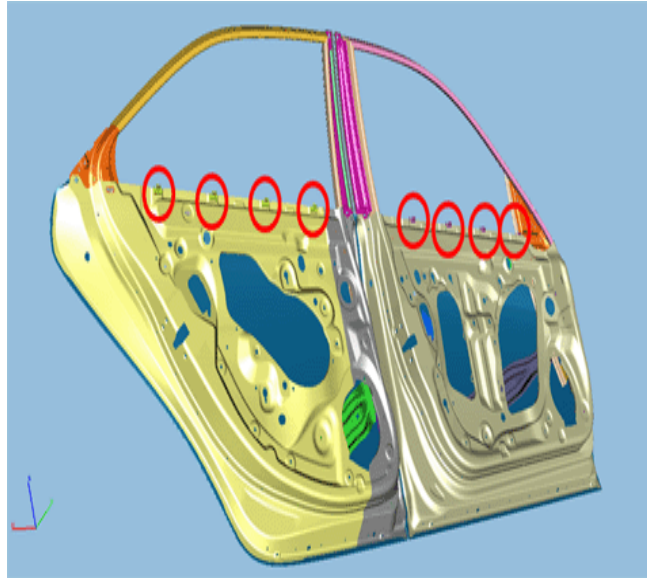
2911982

The interior door trim panel may exhibit a squeak or creak noise when pressing down on the top of the door trim panel (such as might occur when resting one's arm on the door trim). The noise is caused by non-coated door clips.

Note: There may be felt on the door and/or window inner sealing strip. The felt can be left in place for both locations.

2. Replace the clips (4 per door) with the dull finish clips
3. Reinstall the interior door trim panel by referencing the appropriate Side Door Trim Replacement procedure in SI.
