Service Bulletin

Bulletin No.: PIC5810

Subject: High Effort Required For Automatic Transmission Shifter Operation

Models: 2013 Chevrolet Camaro
Equipped with Automatic Transmission

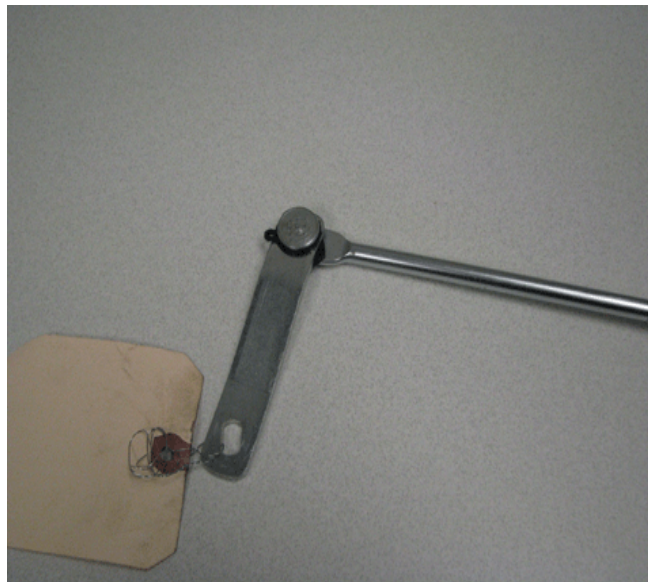
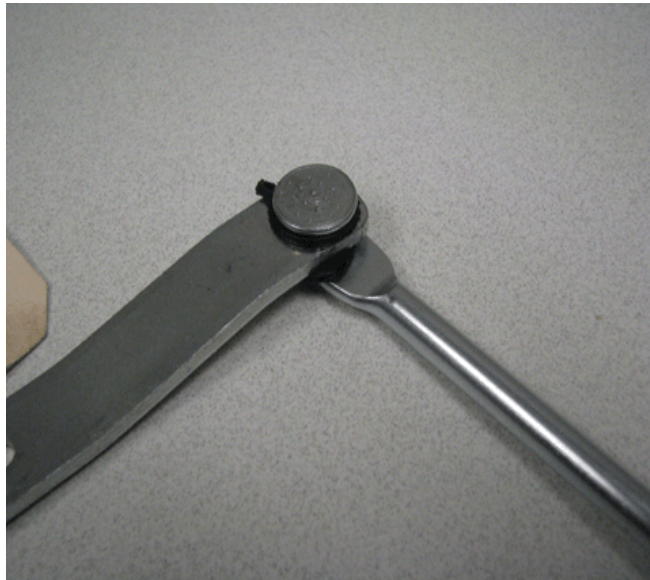
If this concern can be duplicated, dealership technicians are to inspect the end of the automatic transmission shift rod and see if it pivots freely. Two pictures of this rod end and joint can be seen in the photos below.

To inspect this component, the automatic transmission range selector rod must be disconnected from the transmission itself. This is done by first removing the manual shift shaft nut followed by removing the shift control linkage from the transmission. Once this has been done, technicians will be able to feel if the end of the rod is free to pivot back and forth easily. If the rod will not pivot easily, lube the joint and move it back and forth several times. If this rod will still not pivot easily, replace the shifter rod assembly.
