TECHNICAL BULLETIN
 UPS0911-6bNAS6
 19 SEP 2013

Update Prior to Sale: Instrument Cluster Telltales (NHTSA #11V-239)

XJ Range (X351)

Model Year:	2010-2011
VIN:	V00047-V20095

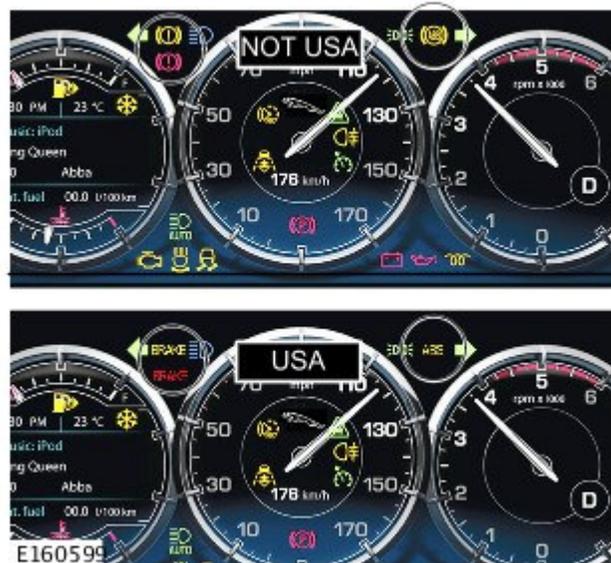
11.

**NOTE: The brake warning lamp text is visible during the Instrument Cluster bulb check.**

After the update has completed, cycle the ignition 'OFF' and then 'ON'; verify that the yellow and red brake warning lamps now appear as text rather than icons.
