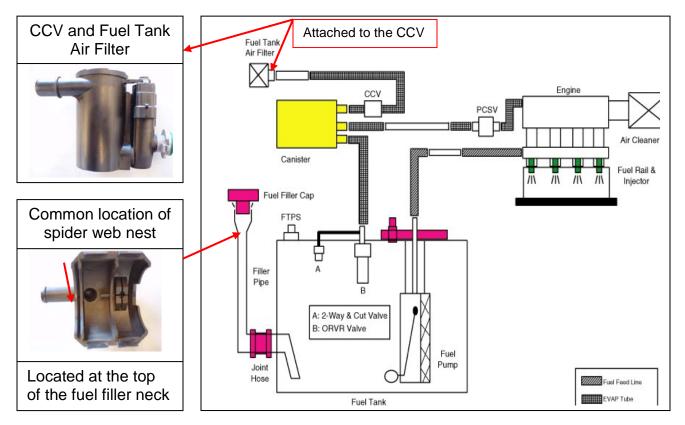
Some Sorento (XM) vehicles may set a DTC flow P0449 or P2422 which may be caused by spider webs in and around the evaporative emissions vent lines creating the set DTC. To repair this condition, inspect the air filter assembly (Located on the CCV) and the evaporative emissions vent lines for spider webs or debris before replacing any components. The spider webs needs to be cleared from the lines with a pipe cleaner, wire or replacement of the restricted component (blowing compressed air through the lines is often ineffective).
