GROUP Brake System	MODEL 2011MY Sorento (XM)
	NUMBER PS252	DATE May 2013

SUBJECT: 2011MY SORENTO STOP LAMP SWITCH INOPERATIVE AFTER PERFORMING CAMPAIGN SC098

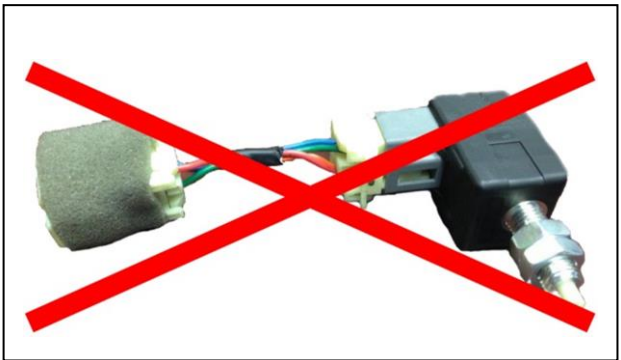
This article provides information regarding a small number of nonfunctioning stop lamp switches in Sorento (XM) vehicles, after performing Voluntary Safety Recall Campaign SC098. It is possible that in some cases, as a result of a previous improper repair, an incorrect stop lamp switch, originally supplied only for 2006-07MY Sorento (BL) vehicles, was installed in 2011MY Sorento vehicles. The stop lamp switch in question has a pigtail (see image) and installation of this pigtail into the new solid state switch results in a reversal of polarity at the switch. Polarity is critical for the correct operation of the new switch and, therefore, it will not function as intended if the pigtail is used.

P/N 93810 3K300QQK
Only applies to 2006-07 Sorento (BL)
Do not use in any other application

If you encounter a situation as described above, remove the switch and pigtail from the vehicle's wiring harness and discard them. Plug the vehicle's wiring harness directly into the new stop lamp switch as described in Voluntary Safety Recall Campaign SC098. Once installation is complete, verify proper operation of the stop lamps.
